# Post-Earthquake Bridge Inspection

Ching Chao, PE, MS; Vinh Dang, PE

Office of Structure Maintenance & Investigations, Caltrans

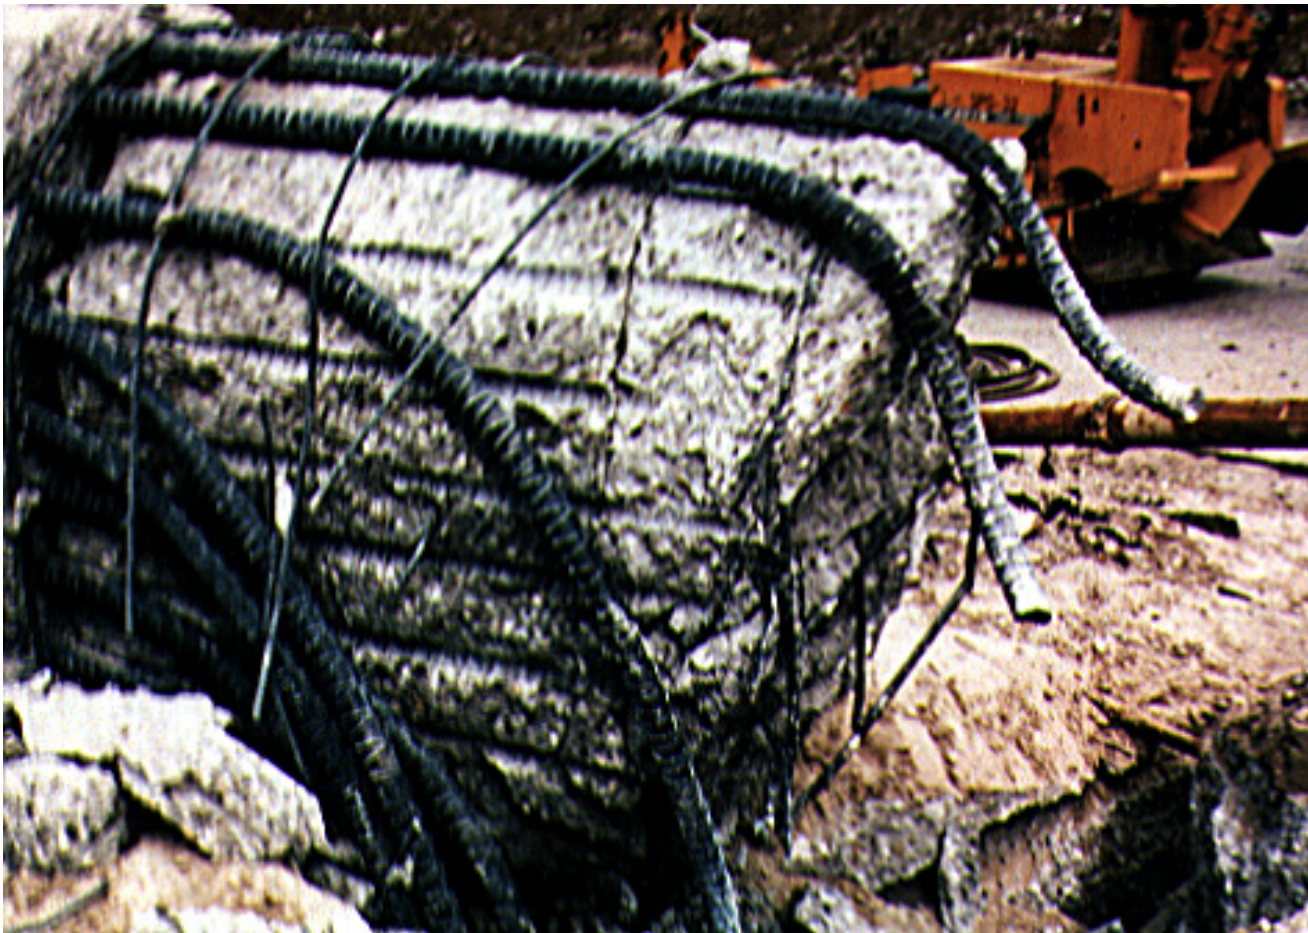
## *San Fernando Earthquake Rte. 210/5 Separation & OH*

### Anchorage Failure at Base of Column

Lap Splices at Base or Lack of Development  
into the Footing

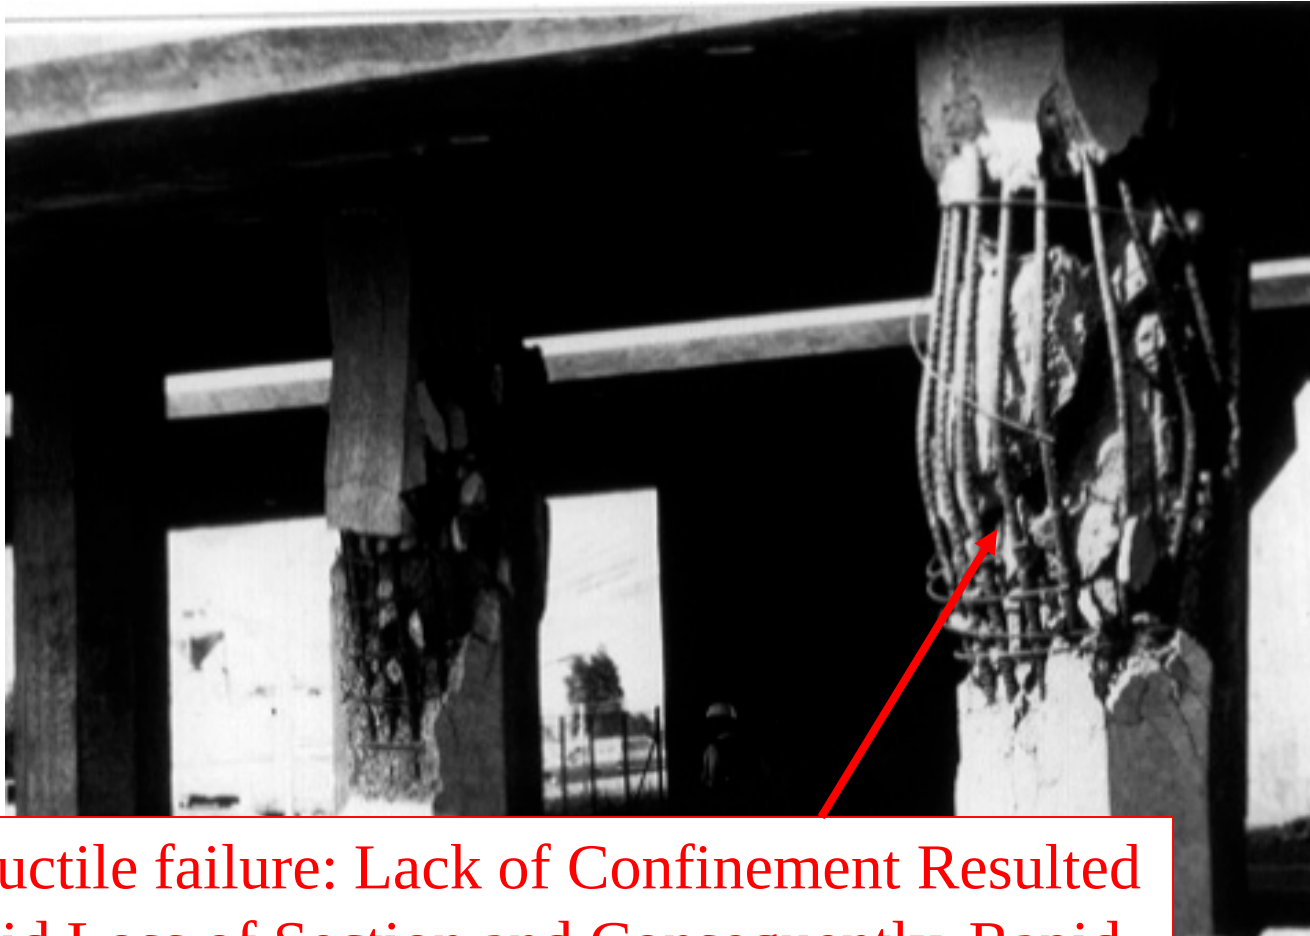
*Route 5/210 Interchange - Foothill Blvd. UP*

Non-ductile failure: Lack of Confinement Resulted in Rapid Loss of Section and Consequently, Rapid Loss of Strength.

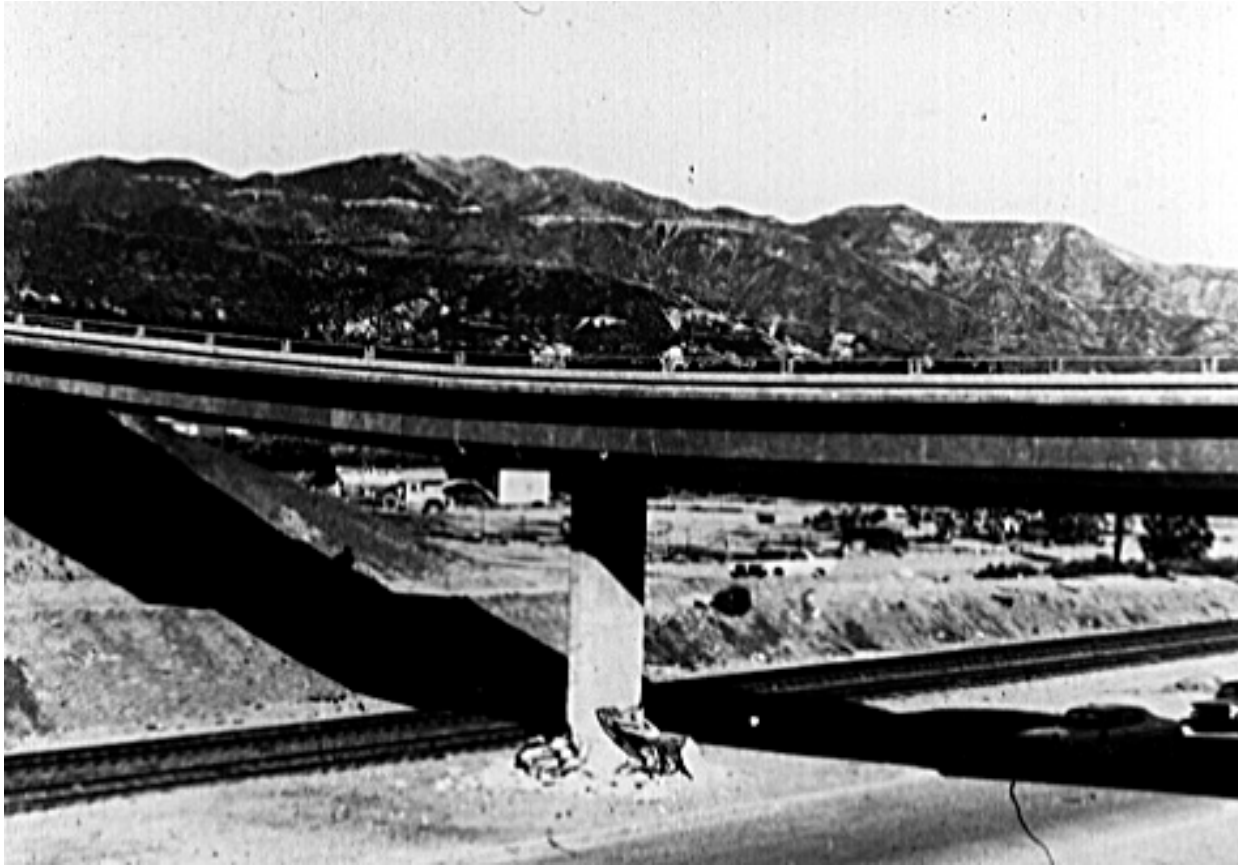
## *San Fernando Road OH (Route 210)*

*Lack of Confinement*

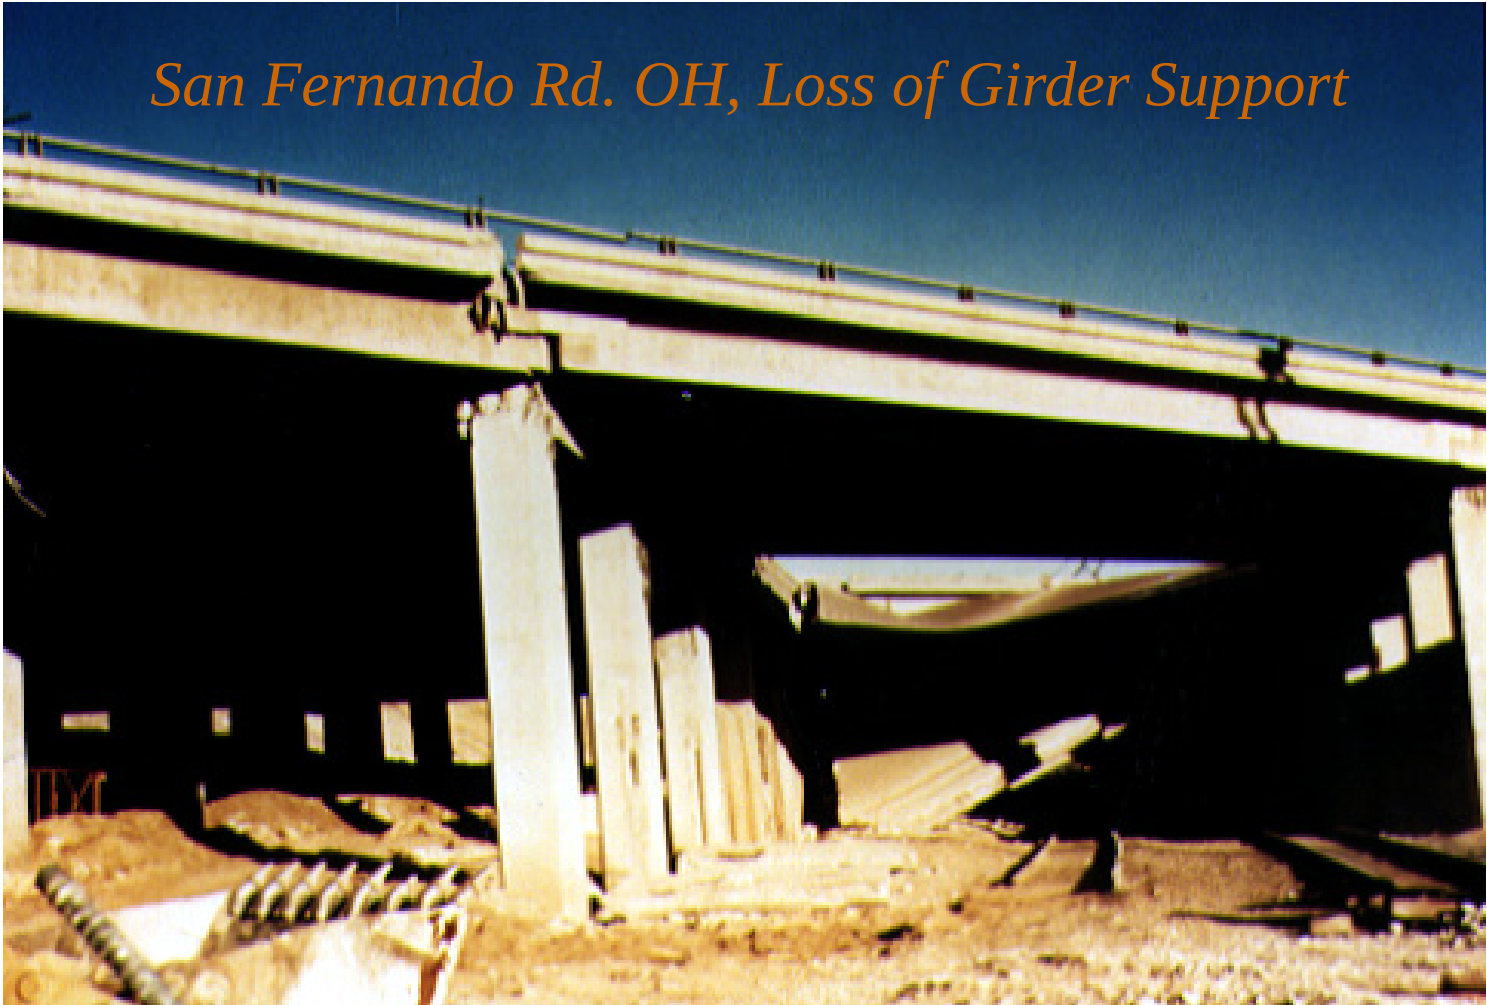
*San Fernando Rd. OH, Loss of Girder Support*

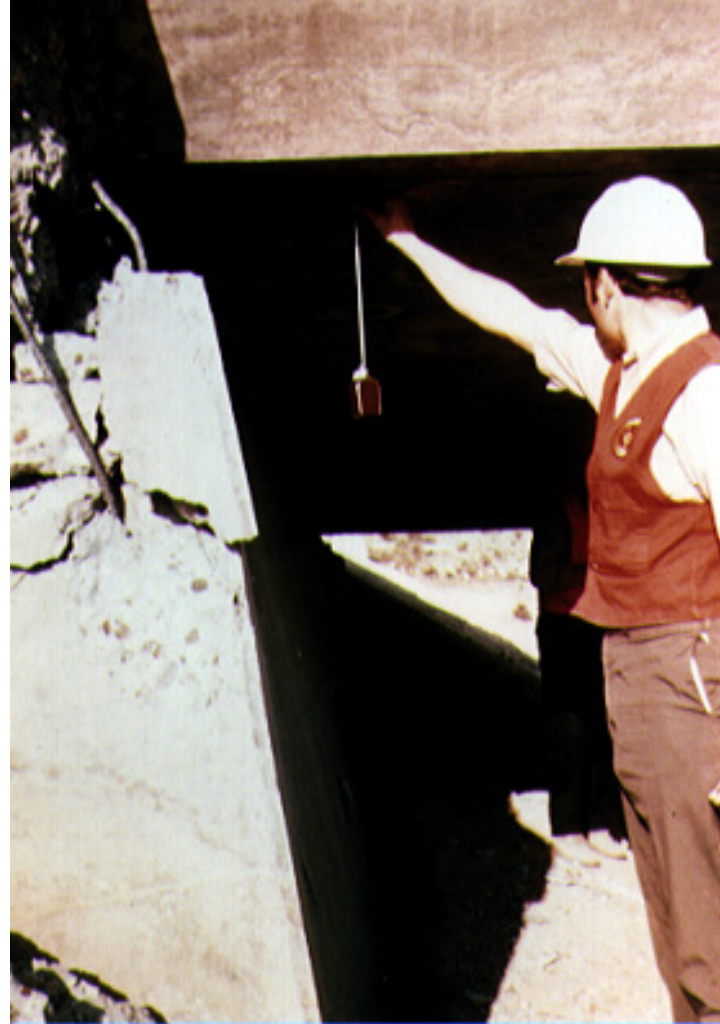
*Balboa Blvd. OC, South  
Abut Failure in Shear of  
Superstructure and End  
Diaphragm at Soffit*

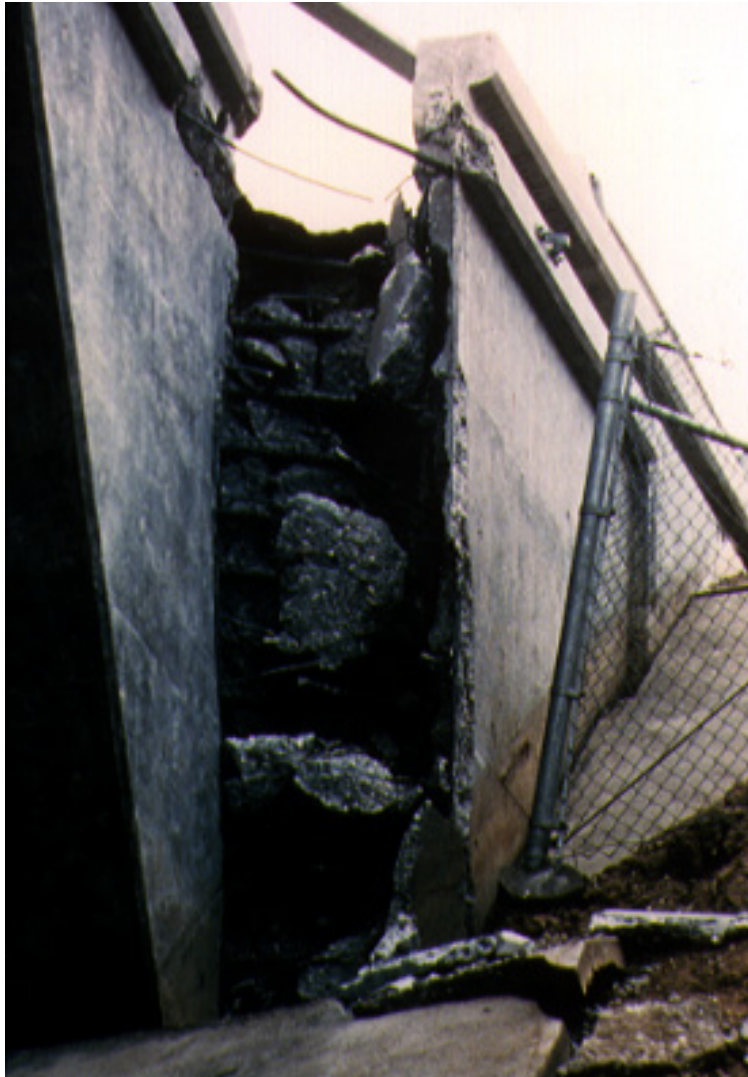
*210 Interchange*

*Wingwall Damage at  
Abutment*

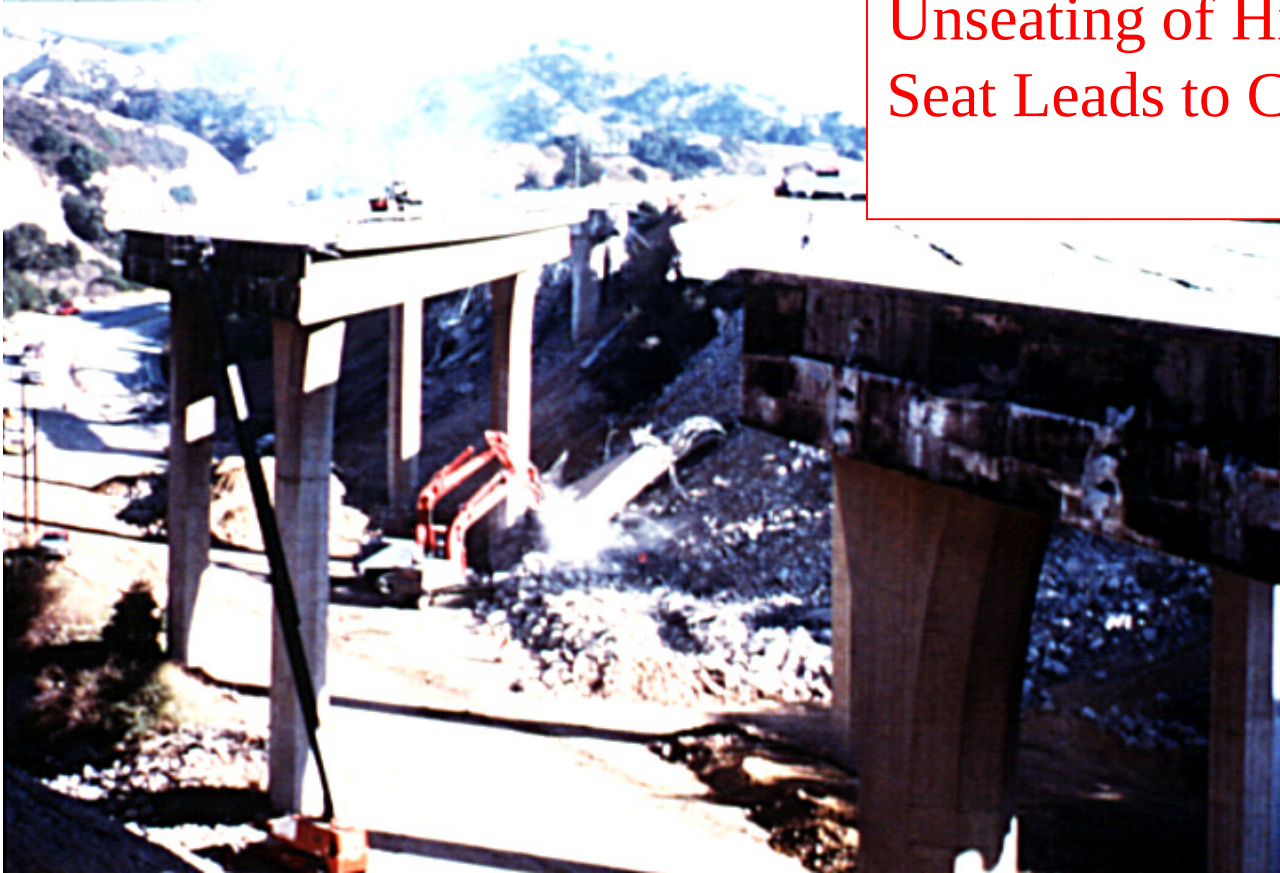
Gavin Canyon Undercrossing – Year Designed: 1965

Unseating of Hinge  
Seat Leads to Collapse

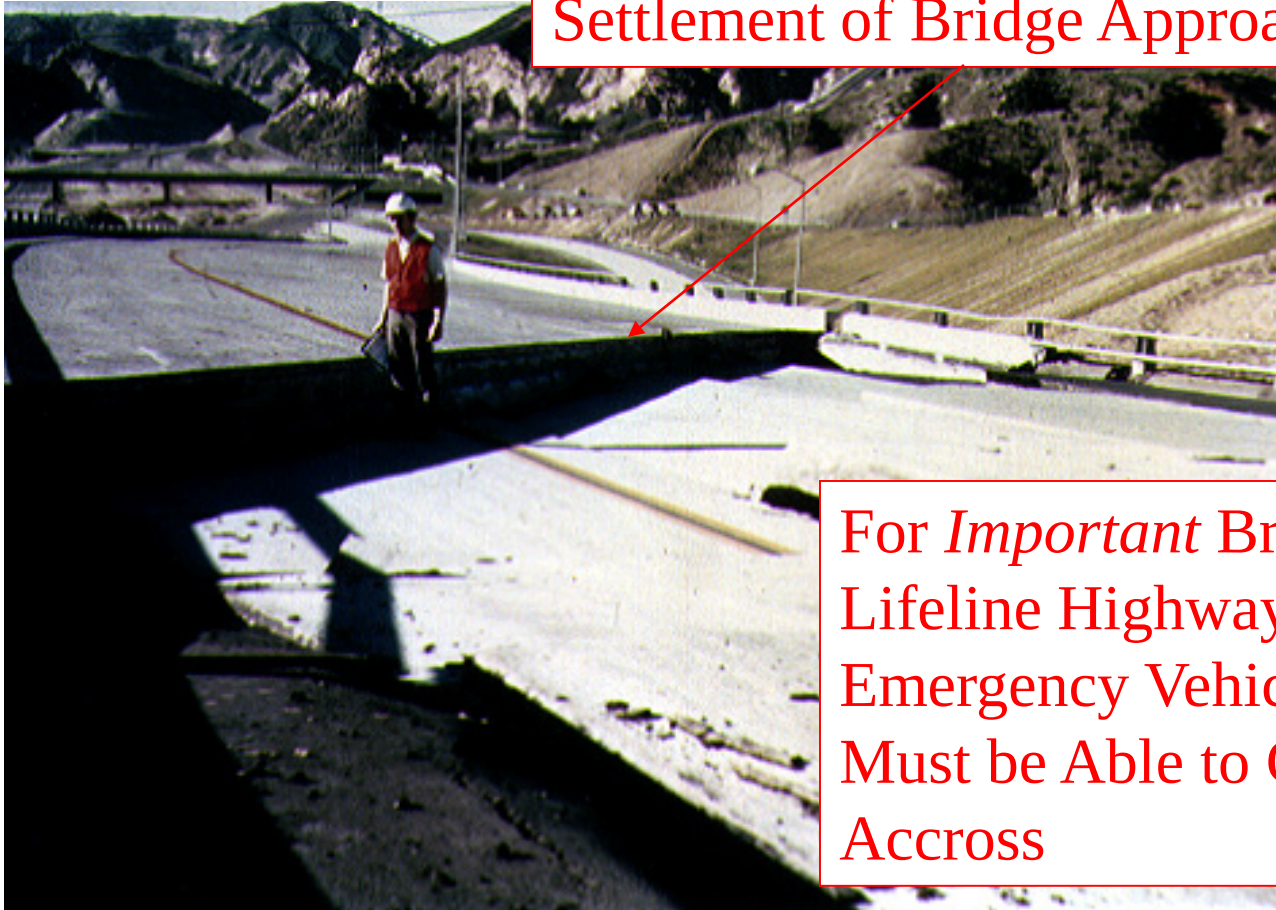
*San Fernando Earthquake Rte. 5/210*

Settlement of Bridge Approach Slab

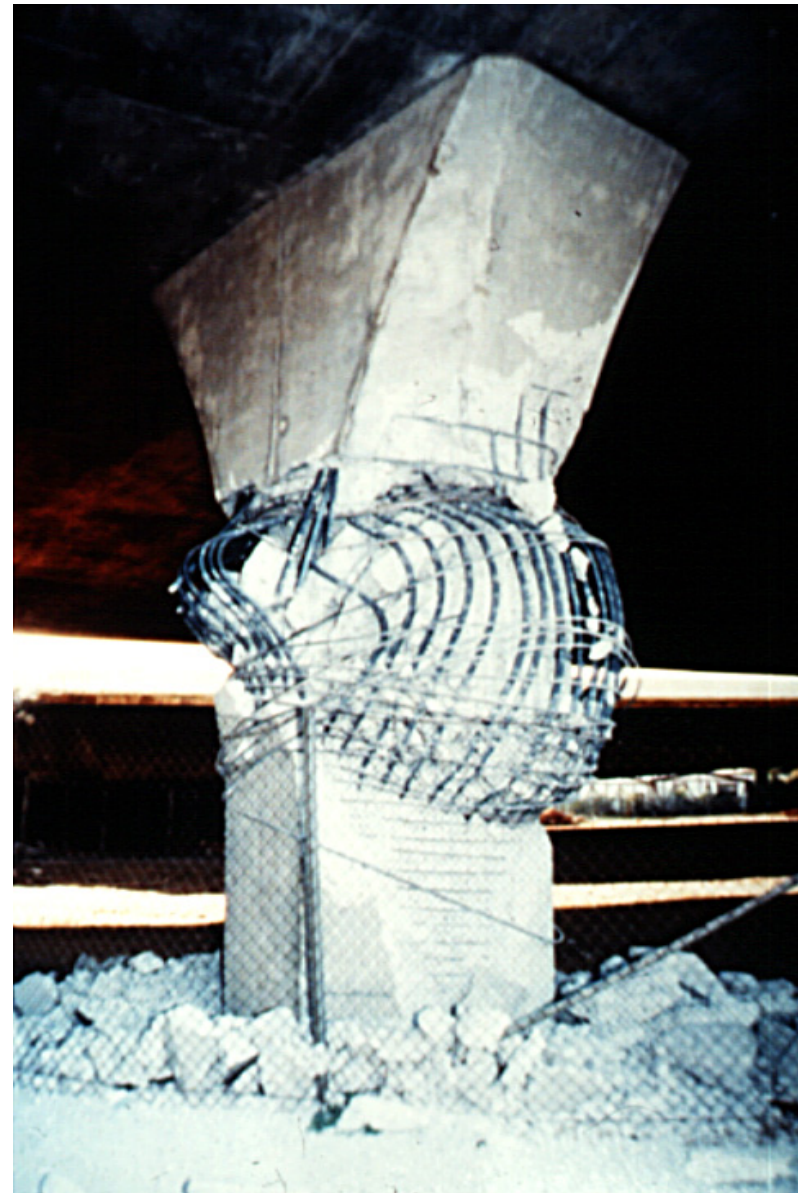
Mission-Gothic  
Undercrossing – Column  
Failure before Architectural  
Flare
