**Build Change, AARGI, and EERI
Earthquake Reconnaissance Report:
M6.5 Pidie Jaya Earthquake,
Aceh, Indonesia on December 7, 2016**

May 2017

A product of the EERI Learning From Earthquakes Program

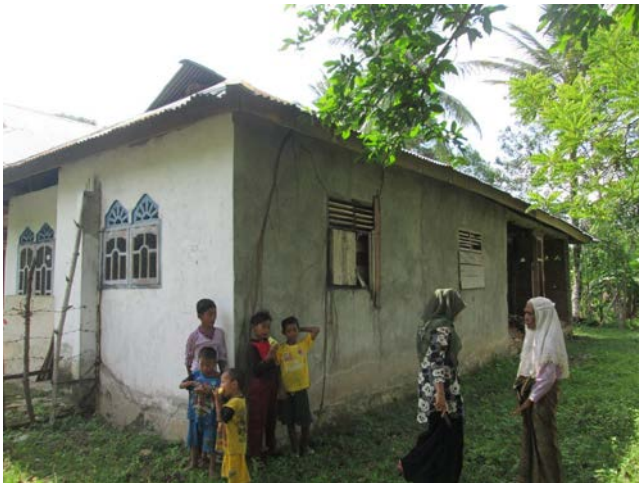
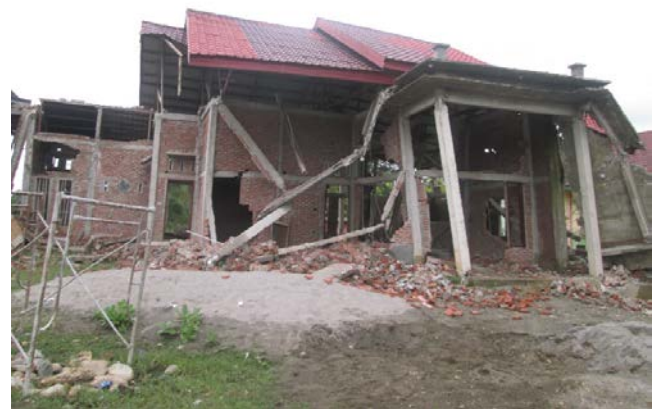
Confined or partially confined masonry houses and schools suffered a range of structural damage from minimal to collapse (Figure 3 and Figure 4). One of the more commonly observed damage for houses was out-of-plane wall failure due to failure of very tall or very long and slender walls (3.5-4 m high, 10 cm thick, with h/t ratio of 35 to 40) or failure of the upper ring beams which were not sized or reinforced with enough capacity to span the longer distances present (either along the span or at the joint). In some cases, walls supporting the roof dead load appeared to perform better than walls which were more lightly loaded axially (Figure 5). One particular out-of-plane failure that was common in both houses and schools was collapse of the masonry gable wall. While many gable walls had vertical reinforced concrete elements extending up through them, this appeared to be ineffective in preventing collapse (Figure 6) since the vertical concrete elements were small and minimally reinforced, thus providing insignificant lateral stiffness to the panel.

Figure 3. (a) Confined masonry house with minimal damage and (b) with severe damage (photos: Build Change).

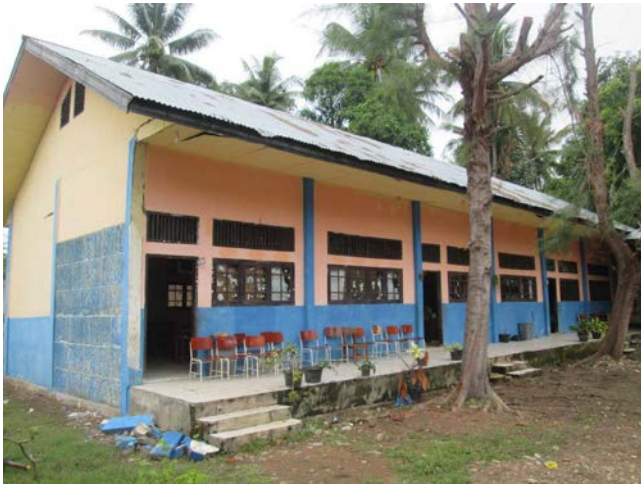
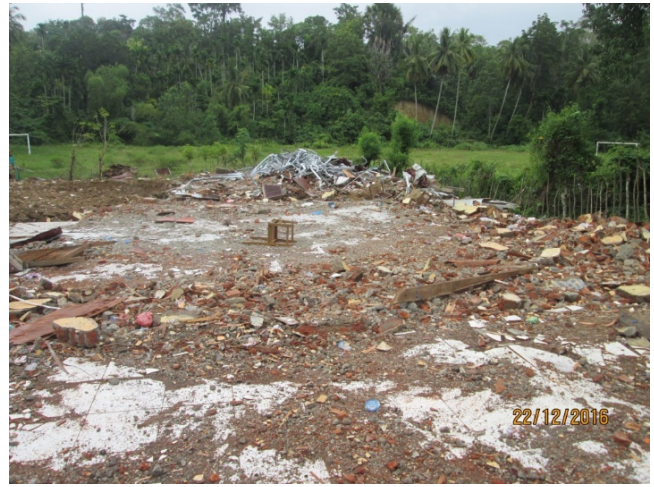
Figure 4. (a) Confined masonry school with minimal damage and (b) collapsed school (already cleared) (photos: Build Change).

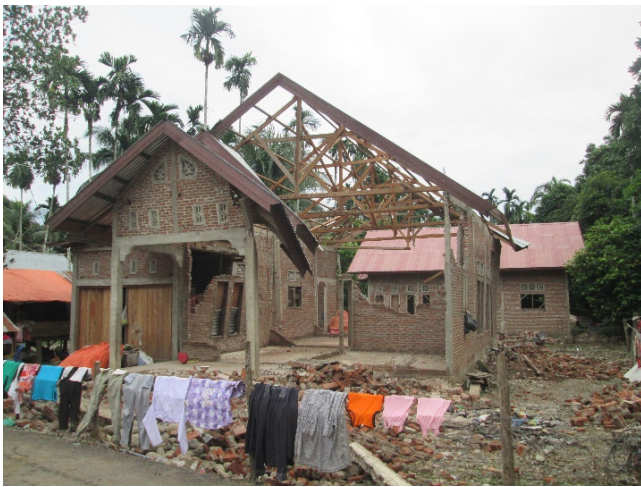
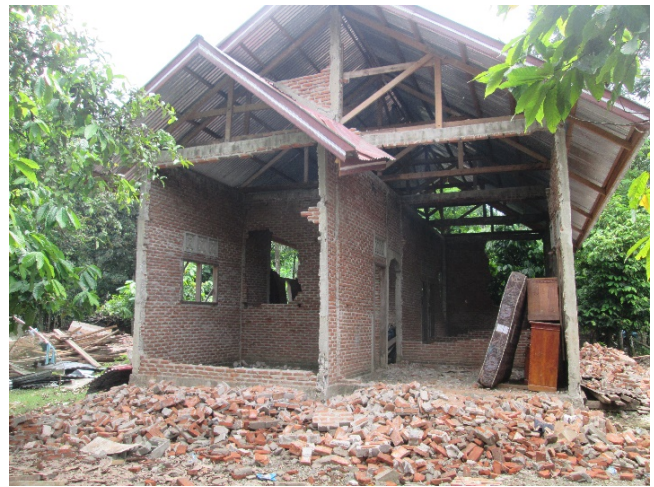
Figure 5. Confined masonry houses where walls supporting roof trusses performed better than other walls which suffered out-of-plane failure: (a) ring beam failure and (b) wall panel failure (photos: Build Change).

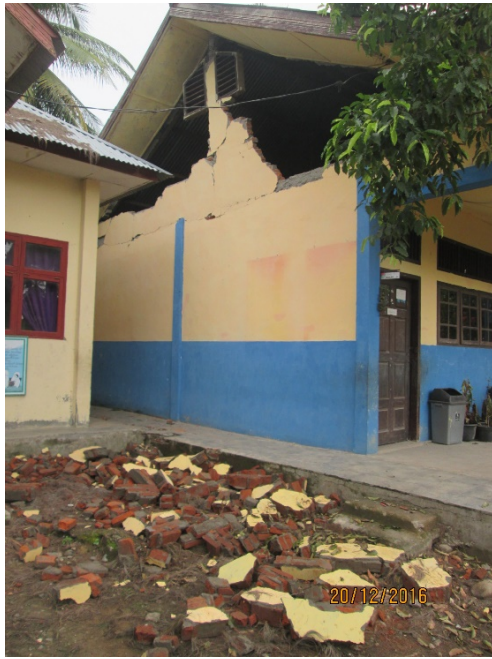
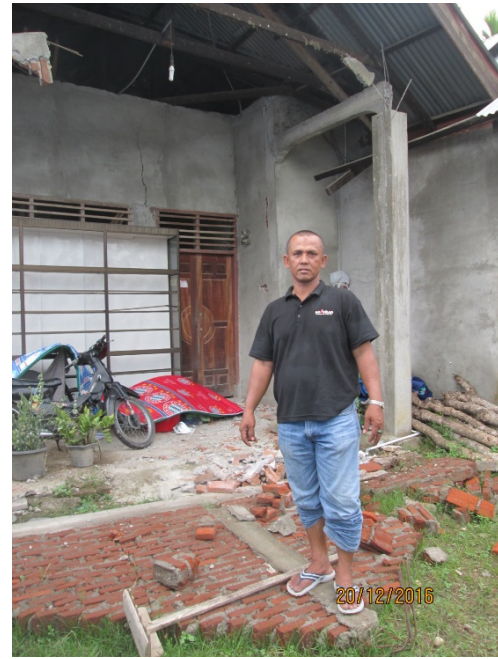
Figure 6. Collapsed masonry gable wall in (a) a school building and (b) a residence (photos: Build Change).

- Gable walls should be constructed of light materials.
- Although it is important for classrooms to have adequate windows and ventilation, it is also important that lateral-resisting elements, such as confined masonry shear wall panels be provided along the longitudinal sides of the classroom buildings.

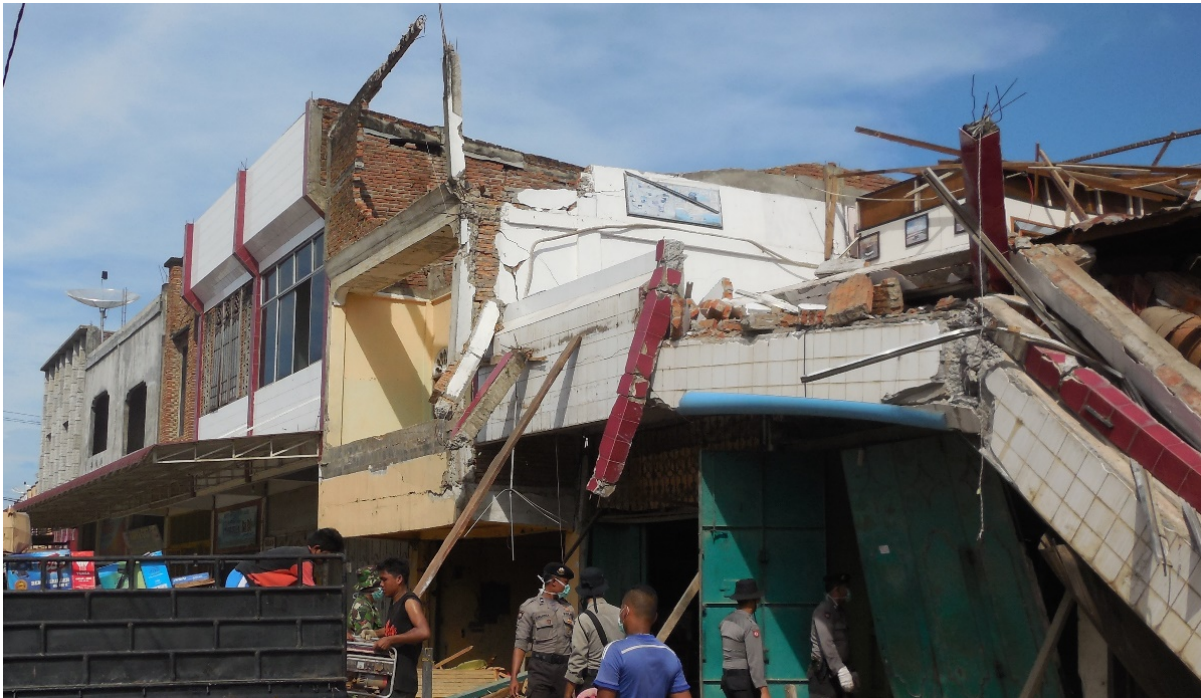
The practice of confined masonry construction is also common on low-rise shop-houses (typically 2-3 stories). This type of building is typically used for commercial purpose on the first story and residential purpose on the upper stories. Similar to the typical damage observed in other past earthquakes, the failure was attributed to soft-story mechanism of the first floor where wide opening exists as the main entrance for the commercial activity. Figure 7 shows the typical shop-houses in the affected area. BNPB reported that 78 shop-houses (BNPB, 2016) were damaged due to the earthquake. This number is relatively small compared to the number of damaged residential houses of 19,000 (BNPB, 2016). In the survey, the AARGI team observed that additional floor constructed above the existing building might have caused the damage because there were similar unmodified shop-houses located near the damaged ones that were unaffected by the earthquake. This additional floor changed the dynamic characteristics of the structures, and there was a great possibility that the existing structural components were not designed to carry that additional load (Figure 8).

Figure 8. Damages on the some shop-houses that have been modified from existing construction (photo: Muhammad Riyansyah).

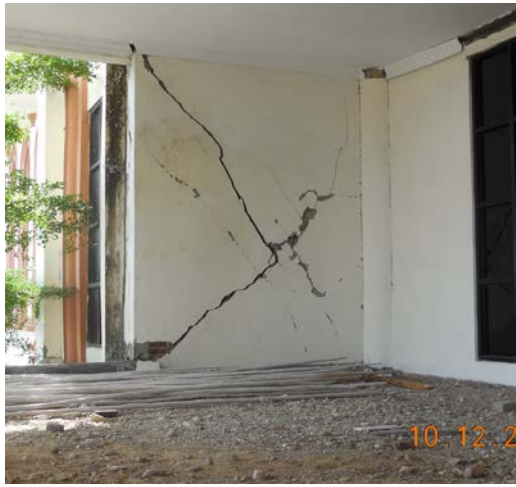
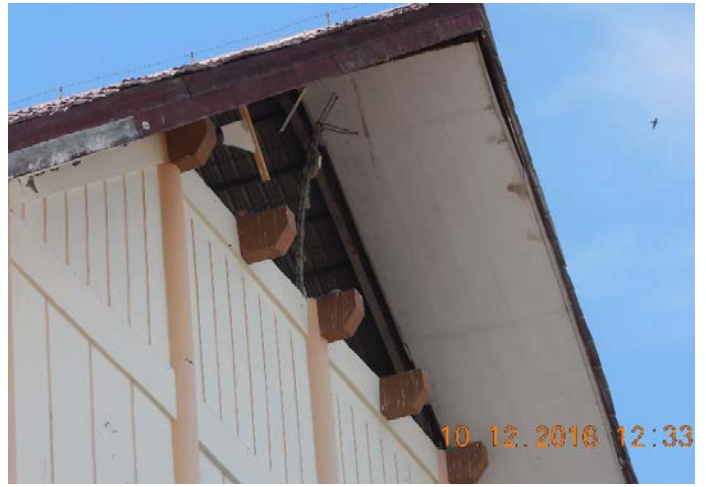
AARGI surveyed 8 government offices, a low-rise school building, and a mosque that were constructed using reinforced concrete and masonry infill. Most damage was characterized by failure of non-structural components, such as damage on the masonry infills, gable walls, and ceilings (Figure 9 and Figure 10). The damage on the ceilings may be caused by fallen debris from the gable wall or poor detailing of the ceiling framing system.

Figure 9. Damage on infill and gable wall of reinforced concrete building (photos: Muhammad Riyansyah).

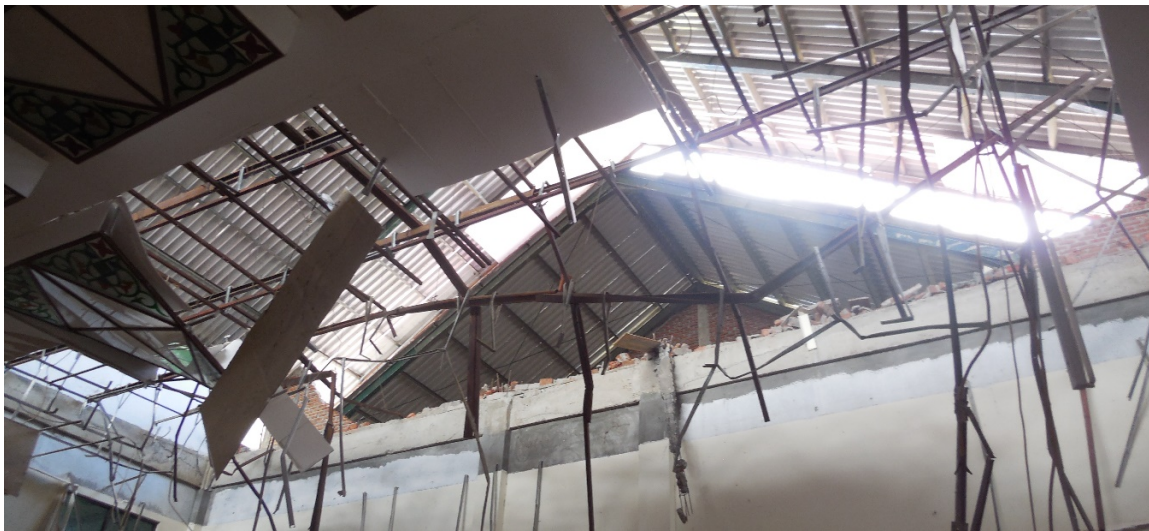
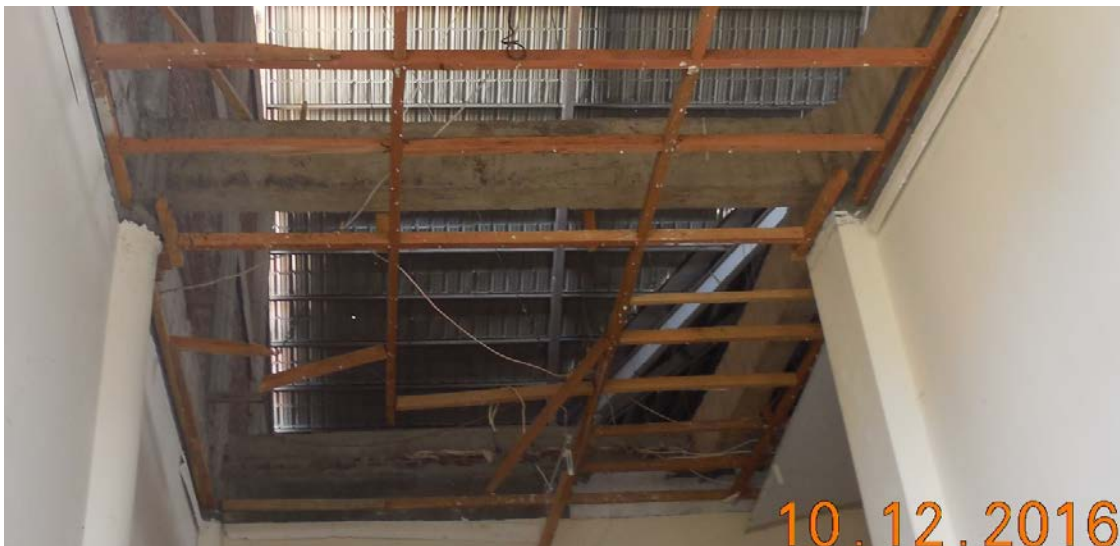
Figure 10. Damage to the same ceiling in both (a) and (b) (photos: Muhammad Riyansyah).

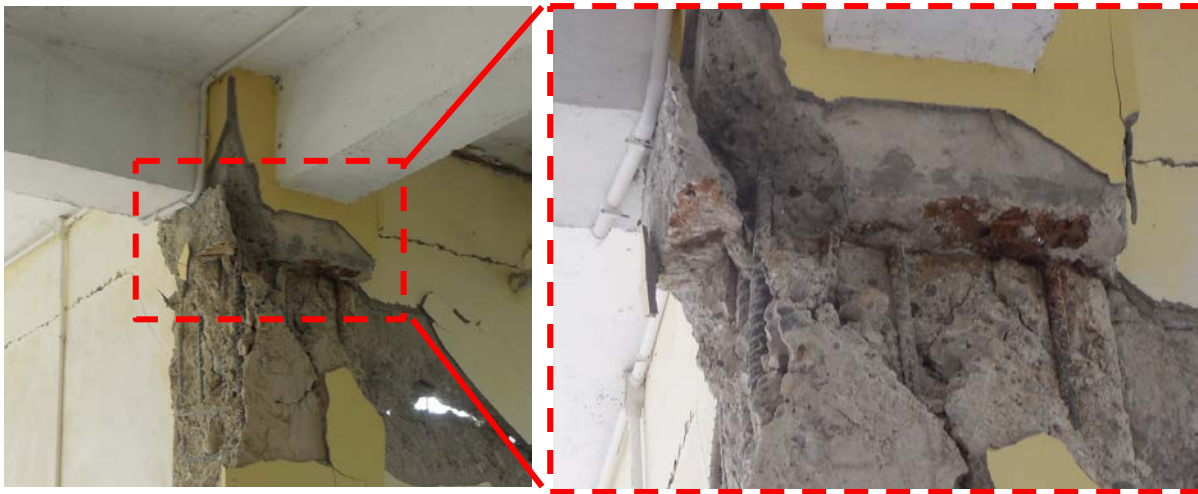
This failure was observed in a government office. The failure was characterized by spalling and bursting of construction joints where the rebar was spliced, near the beam-column connections (Figure 11). Poor design and detailing may contribute to this failure, considering that the location of the construction joint is close to a highly stressed region of the building. Poor construction quality, indicated by debris in the connection, may also worsen the quality of the joint.

Figure 11. Construction joint failure (photo: Muhammad Riyansyah)

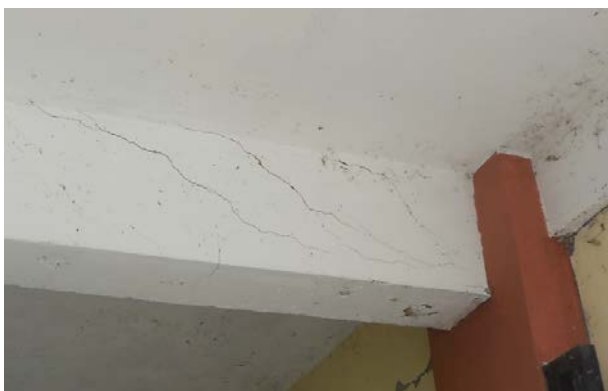
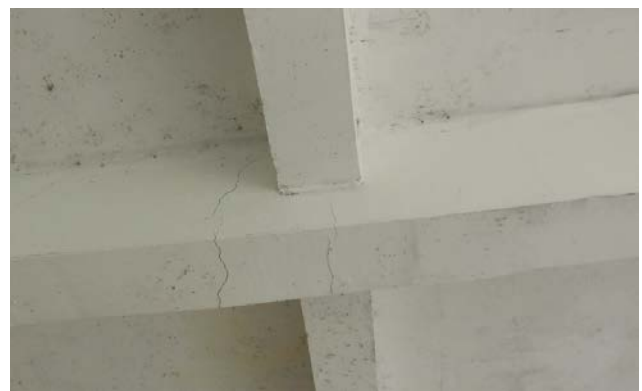
This failure was observed in the same government building in which the construction joint failed. Shear and flexural cracks (Figure 12) were observed on some beams located at the basement of that building. However, shear cracks were observed more often during the survey. Poor detailing may be the main factor that caused these cracks.

Figure 12. Shear and flexural cracks on a beam (photos: Muhammad Riyansyah).

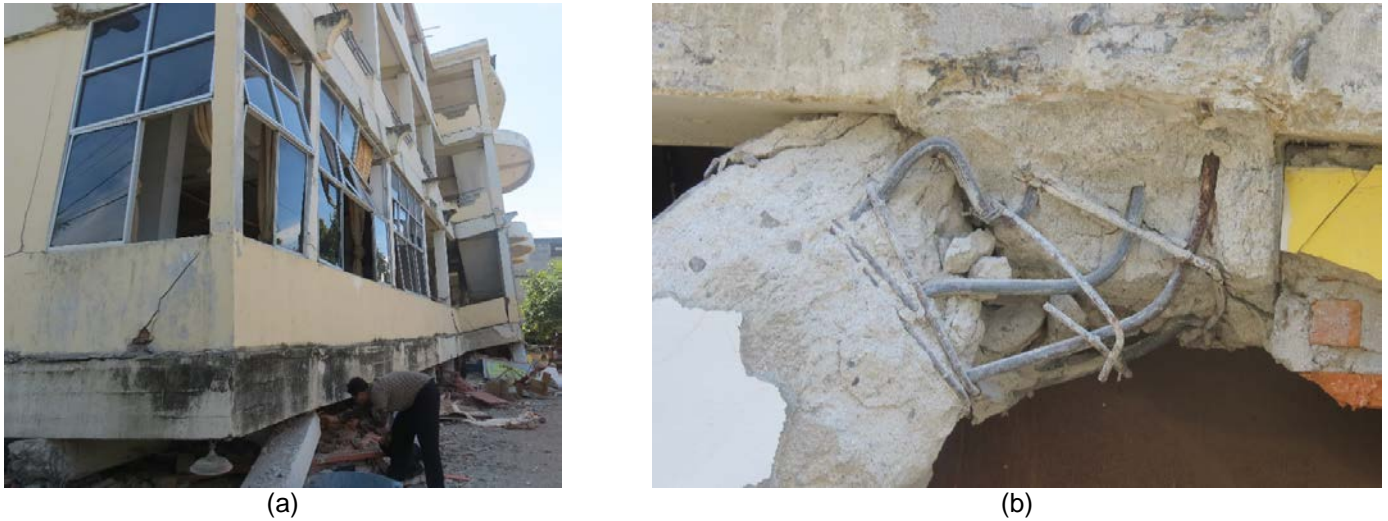
Soft-story mechanism was observed on a four-story college building and a mosque. The first story of the school building collapsed as shown in Figure 13. Based on the observation, poor structural configuration and reinforcement

detailing contributed to this failure. It is also important to note that the rebar used in most collapsed buildings was undeformed rebar, both as longitudinal and transverse reinforcements.

Figure 13. Soft story collapse on a low-rise reinforced concrete building: (a) overview of collapse, (b) mangled rebar due to collapse (photos: Puskim Kemenpupera).

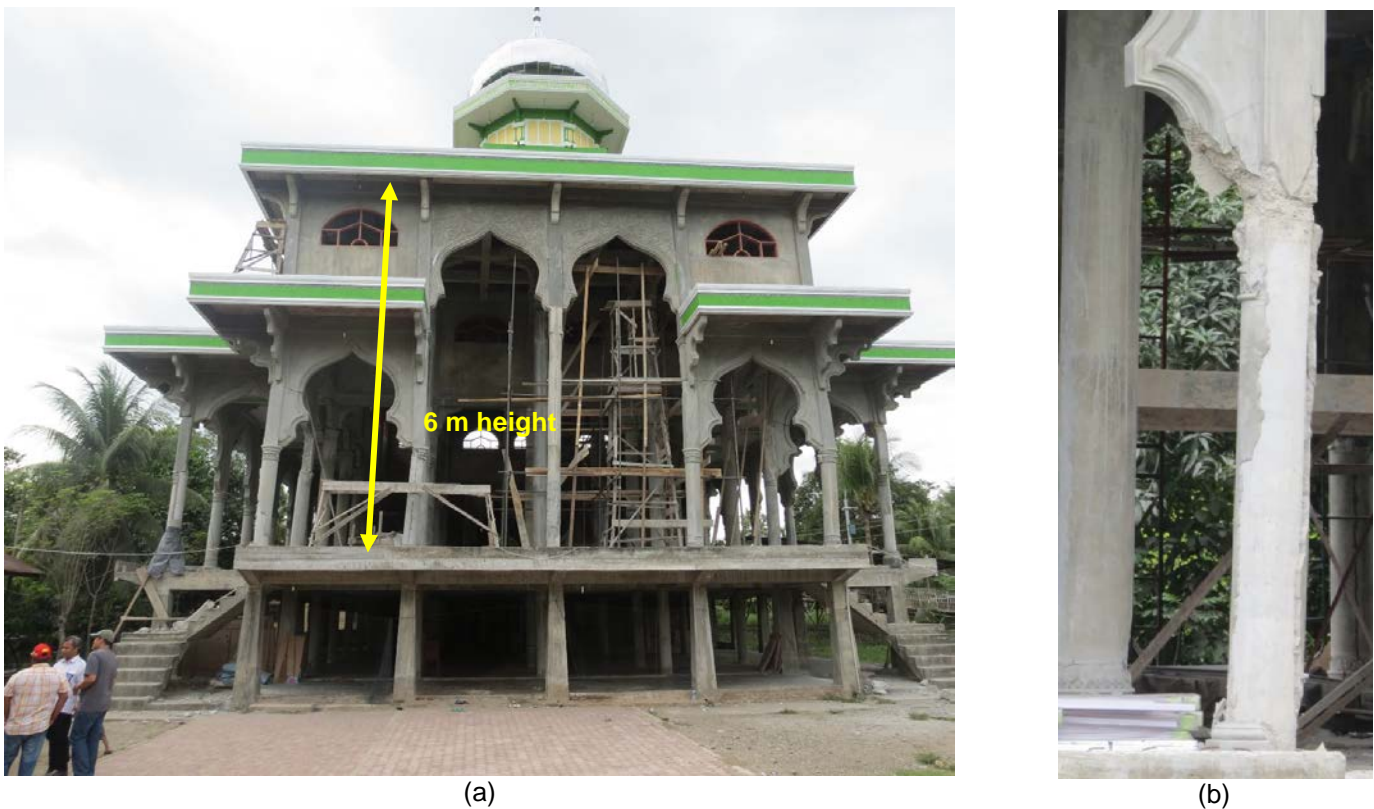
On the other hand, significant structural damage was observed on slender columns of a mosque (Figure 14). At the time of the earthquake, the mosque was still under construction with remaining nonstructural and decoration work. The columns on the second floor were approximately 6 m tall and they had to support a large mass of the roof and the dome. More detailed investigations showed that the slender column was poorly detailed with inadequate longitudinal reinforcement, largely spaced transverse reinforcement, and the use of undeformed rebar (Figure 15).

Figure 14. Soft story effect on a mosque structure: (a) overview of mosque with scale, (b) damage to column (photos: Puskim Kemenpupera).

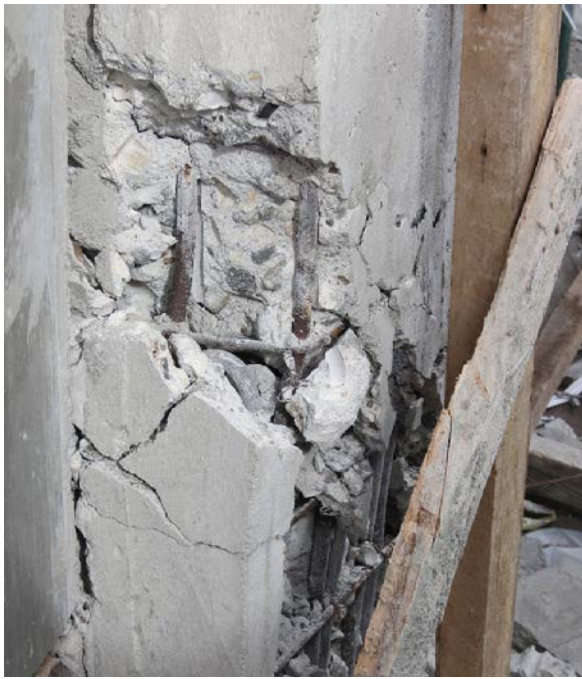
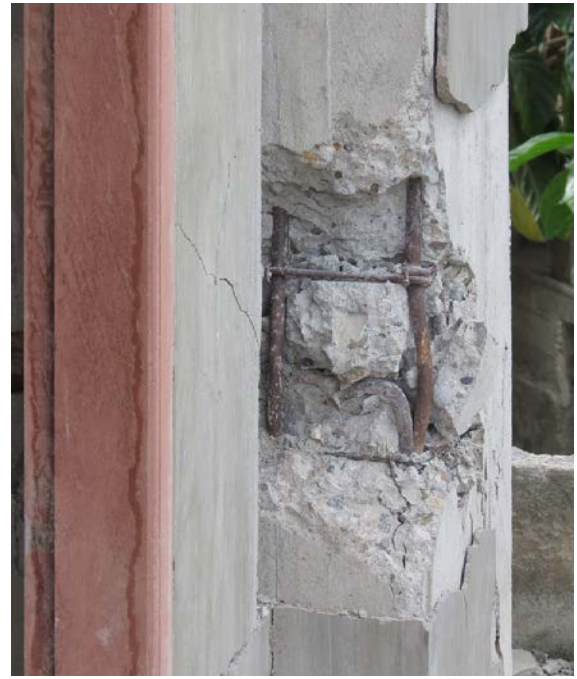
Figure 15. Poor detailing on the slender columns (a) and (b) (photos: Puskim Kemenpupera).

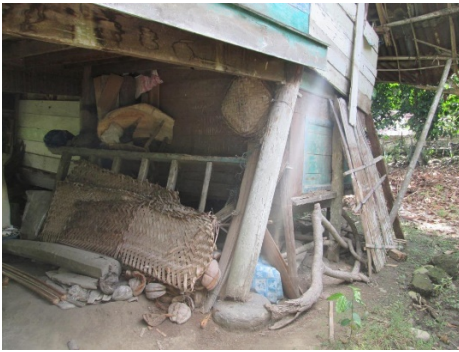
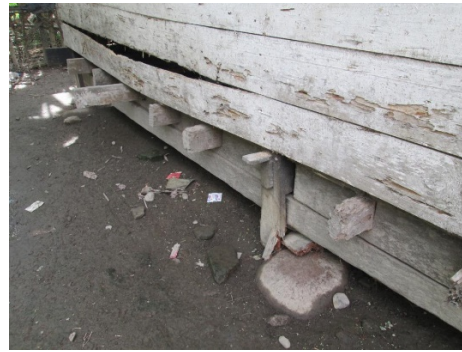
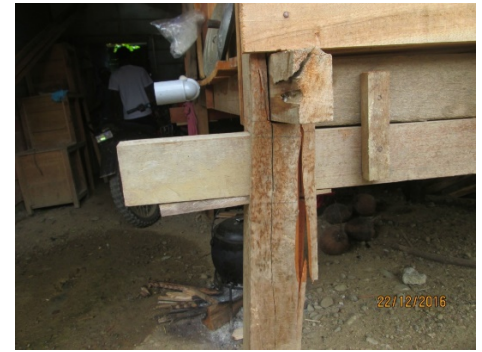
For raised timber houses, the lower level posts were typically unbraced and poorly connected to the foundation, in some cases simply resting on top of stone bases. This led to the observed racking of the lower level, sliding the posts off the bases or unseating of the posts, and in some cases, fracture of the posts due to large drift in the earthquake (Figure 17).

Figure 17. Damage to raised timber frame houses: (a) racking/drift of posts, (b) posts shifted off base, and (c) fractured posts (photos: Build Change).

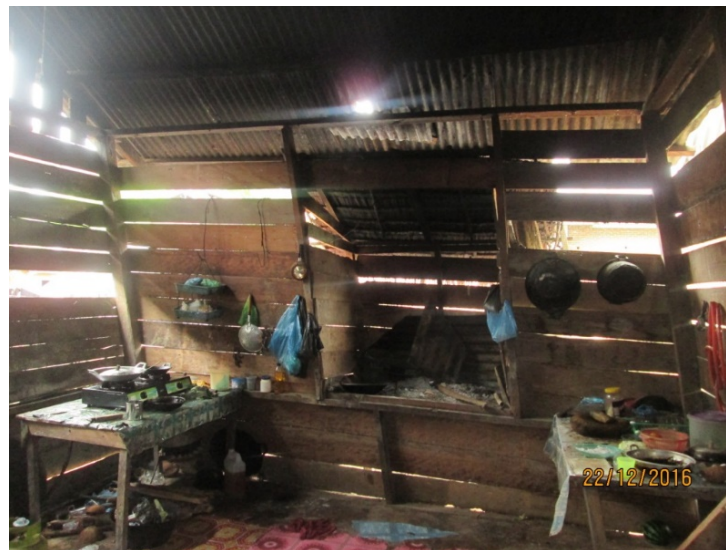
Both raised and on-grade timber buildings typically used horizontal planks as the wall covering. Although horizontal sheathing can provide lateral strength to walls, in many cases the planks did not seem to be sufficiently nailed to the wall framing, or were placed with large gaps between them, reducing the effectiveness of the planks to contribute to lateral strength and stiffness. In some of these cases, racking of the walls and permanent story drift were observed (Figure 18).

Figure 18. Racking in timber framed house (photo: Build Change).

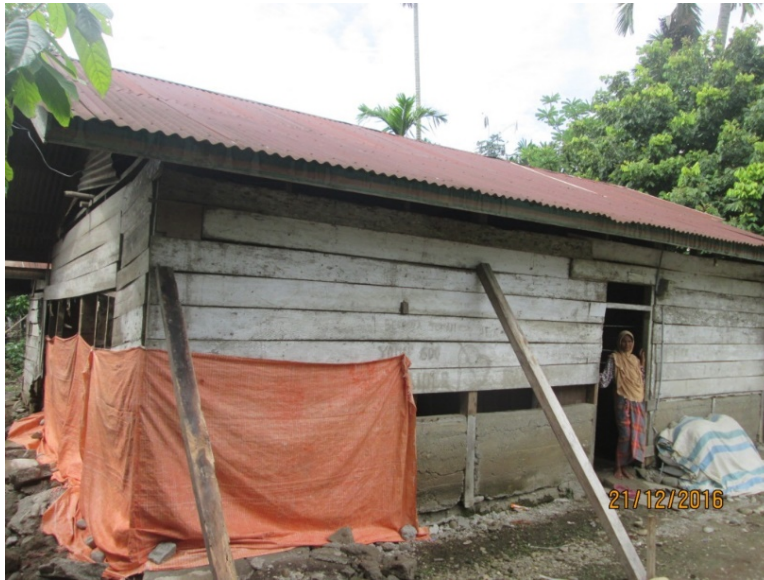
Damage specific to the on-grade timber houses with masonry skirt walls consisted of cracking or partial collapse of the skirt wall – typically due to poor construction of the wall and low quality materials, inadequate connection to the timber posts, and/or a lack of top beam on the skirt wall (Figure 19).

Figure 19. On-grade timber house with partially collapsed skirt wall (covered by tarp) (photo: Build Change).

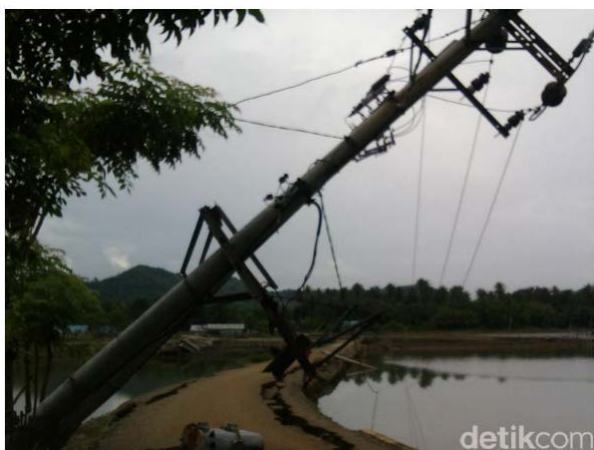
The earthquake interrupted the electrical distribution to over 40,000 customers. It was recorded that 84 transformers, electrical cable lines, and more than 100 low-voltage and medium-voltage electrical poles (Figure 20) were damaged during the earthquake. The damage was concentrated at electrical facilities located in Samalanga, Meureudu, and Beureunun regions. The power distributed in the Samalanga region is 500 kW, and the power distributed in Meureudu and Beureunun is around 6 MW (Jati 2016).² Some retrofit and reconstruction measures, such as reconnecting the broken electrical cable and reconstruction of low-voltage pole, were conducted by the state electricity company (Perusahaan Listrik Negara, or PLN) to recover the interruption. The electrical distribution was 50% recovered within two days after the earthquake, and it was completely recovered within four days after the earthquake (PLN 2017).³

Figure 20. (a) Damage on electrical poles during the Aceh earthquake, (b) recovery efforts conducted by the State Electricity Company (photos: Augustinus 2016).⁴

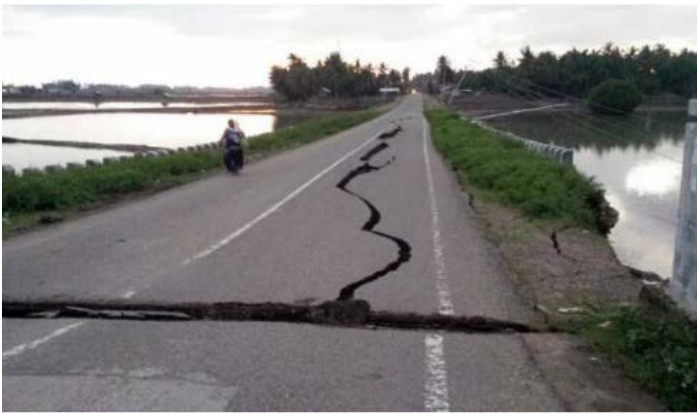
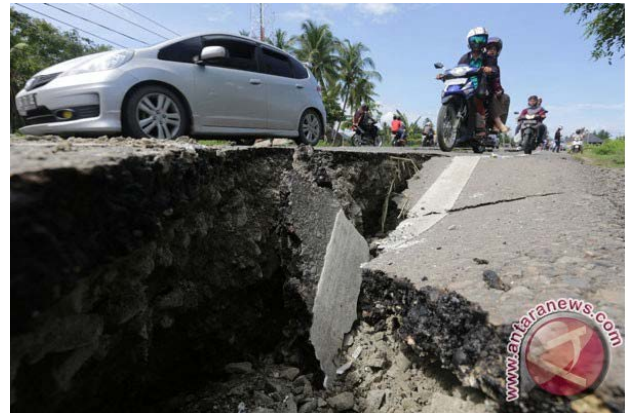
Figure 22 shows the cracks on some roads in the Pidie Jaya region. This earthquake also caused damage on some bridges in Pidie Jaya, Pidie and Bireuen. Efforts were carried out to repair and reconstruct the damaged road and bridges. In addition, the Aceh International Airport located around 100 km to the west of the epicenter was unaffected by the earthquake.⁷

Figure 22. Cracks on the road in the Pidie Jaya region (photos: (a) Siswoyo 2016⁹, (b) Antara News 2016).¹⁰

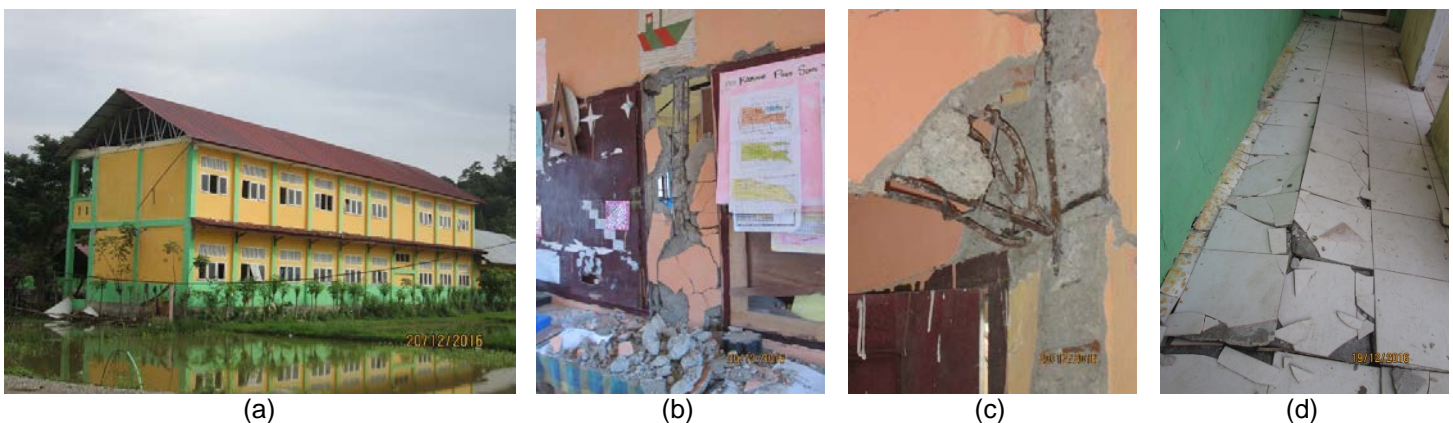
There was relatively little variation in type, configuration, and construction quality of the observed schools. All observed buildings have many windows along the front and back of the building. Although the amount of damage varied, there were commonalities observed, such as the collapse of tall and thin unreinforced masonry walls, the collapse of gable end walls, wall cracks at the openings, cracking through wall piers and at longitudinal cracking at the wall-column interface, damage to beams at column faces, and cracks on the floor due to poor compaction of backfill (Figure 23). The quality of concrete was generally low due to the use of poor quality materials, such as round gravel (Figure 24). Inadequate concrete cover was also observed, exposing corroded reinforcing bars and spalled. It was observed that undeformed rebars were used for both main longitudinal and transverse reinforcement. The use of deformed bars was not observed in the schools visited. Damage to the dropped ceiling systems was also common, where ceiling panels and framing fell into the classroom, possibly due to insufficient support and bracing of the system to the building structure (Figure 25).

Figure 23. Damages at School Buildings: (a) gable wall collapse, (b) failure of wall pier and column, (c) failure of beam to column connection, (d) cracking in the floor slab (photos: Build Change).

Damage can be reduced and collapse can be prevented in the common school building typologies observed with some simple improvements to the observed structures. Construction quality must be improved, such as by providing adequate rebar cover and improved connections between masonry and reinforced concrete elements (toothing or bed joint dowels). Better quality materials, such as concrete, deformed reinforcing bars, and stronger bricks are needed. In addition, adequate detailing of the reinforcement in beam and column joints is required, so that proper bar hooks and lap splices are provided.

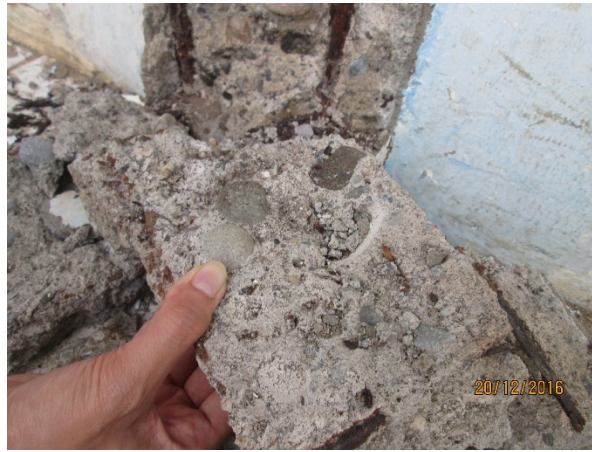
Figure 24. Low quality concrete in school column (photo: Build Change).

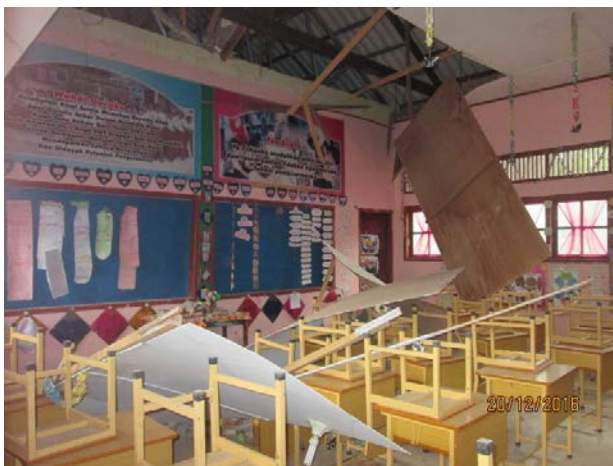
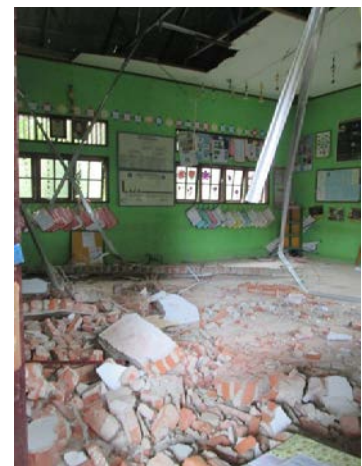
Figure 25. Ceiling damage in classroom buildings (photos: Build Change).

- Dropped ceilings should be supported and braced sufficiently to the building structure.

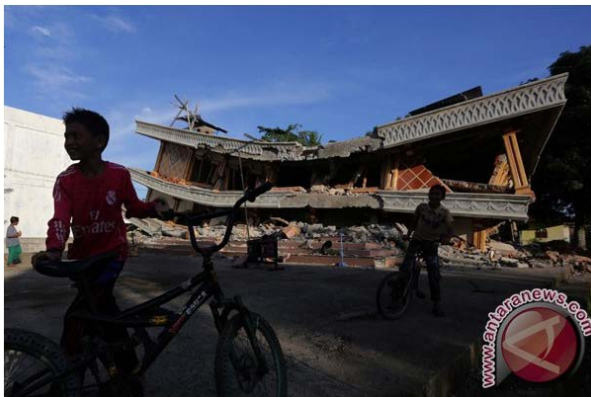
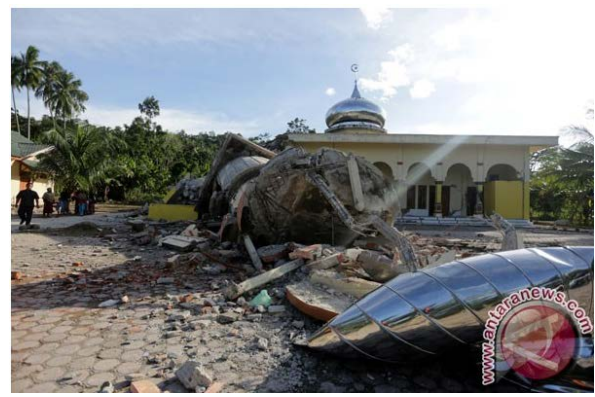
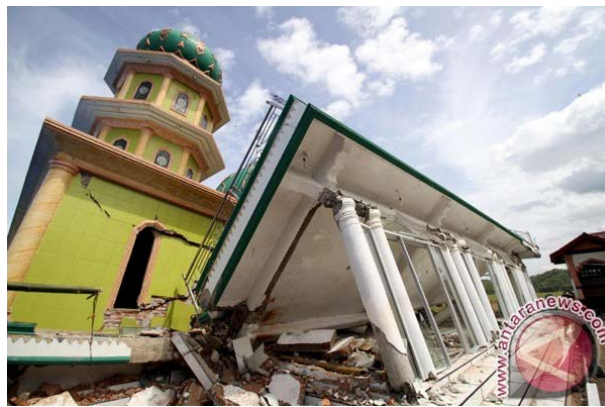
Figure 27. Damage to mosques: a) Damaged mosque at Meuko Kuthang, b) Damage of Mosque Jami Nur Abdullah at Lueng Putu, c) Damage of Mosque Baitul Muttaqin (photos: Antara News, 2016).^{14, 15, 16}
