## PERMISSIBLE RESIDUAL DEFORMATION LEVELS FOR BUILDING STRUCTURES CONSIDERING BOTH SAFETY AND HUMAN ELEMENTS

Jason McCormick<sup>1</sup>, Hiroshi Aburano<sup>2</sup>, Masahiro Ikenaga<sup>3</sup>, and Masayoshi Nakashima<sup>4</sup>

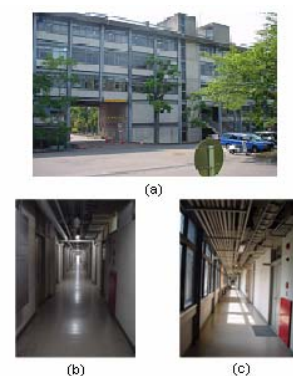
Figure 3 Target Structure: (a) East side, (b) South corridor, and (c) East corridor

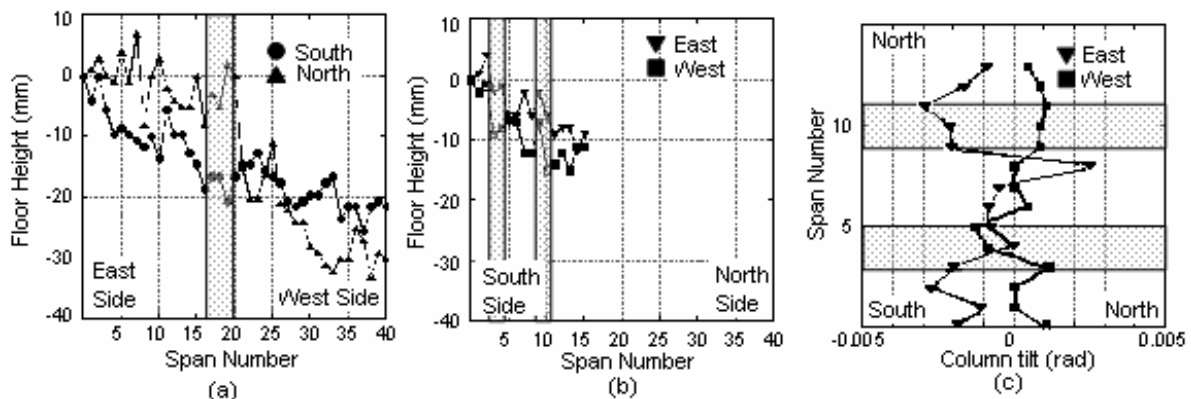
Figure 5 Fourth story (a, b) floor inclination results and (c) column tilt results

Figure 5(a) and (b) provide the change in floor height along the corridor for each side of the building with respect to the initial measurement point (0 mm). The shaded area indicates those spans which are above vehicle openings at the lower levels. Both the north and south corridors sloped downward to the west, while the east and west corridors sloped downward to the north. The resulting inclination angles were 0.00014 rad, 0.0002 rad, 0.00016 rad, and 0.00019 rad for the north, south, east, and west corridors, respectively. All of these values were within the construction tolerances for steel structures. The maximum local change in floor height occurred in the north corridor where the floor height decreased by 20 mm over a single span. This decrease resulted in a local inclination angle of 0.0053 rad which exceeds the permissible residual deformation obtained previously and suggests that the inclination over this span would be perceivable to the occupants.

The tilt of the individual columns along the east and west corridor of the 4<sup>th</sup> story is shown in Figure 5(c). A negative tilt angle specifies that the column leans to the south while a positive tilt angle specifies that the column leans to the north. The shaded areas represent those columns which border or lie above vehicle opening at the lower levels. A total of 8 columns along the east corridor and 0 columns along the west corridor have tilt angles which surpass the construction tolerance (0.0014 rad) designated for steel structures. However, none of these 8 columns are above the permissible residual deformation level of 0.005 rad. The results also show that the 11<sup>th</sup> span column in both corridors had the maximum tilt angle. The maximum tilt angle for the east and west corridor was 0.003 rad and 0.0013 rad, respectively. As a result, the maximum column tilt for the east corridor was 2.3 times that of the west corridor which may be associated with the fact that vehicle openings are larger in the east corridor versus those in the west corridor (see Figure 3).

- 2) The 4<sup>th</sup> story corridor study of the target structure revealed that only at local points did the floor inclination (0.0053 rad) exceed the permissible residual deformation level. Meanwhile, none of the measured column tilt values along the east and west corridors were above the permissible limit. As a whole, the building did not show a significant amount of residual deformation.

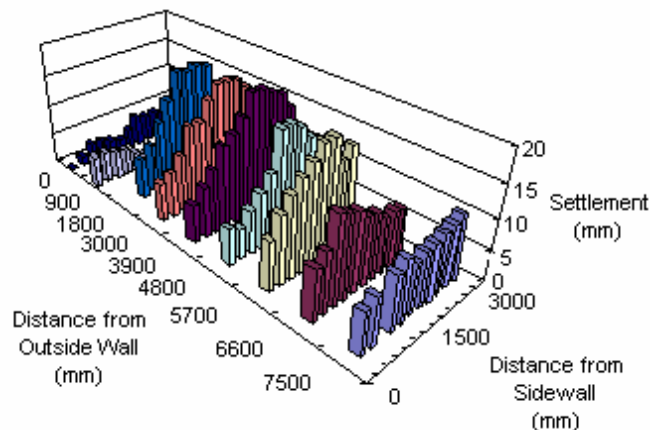
Figure 6 Settlement with respect to position within the occupied office space

Figure 7 provides the results from the study of the occupied office space. The vertical axis represents the floor settlement with respect to the height of the floor at the back left corner of the room (0 mm, 0mm, 0mm). The results show that the majority of the settlement occurred between 1800 mm and 6600 mm from the outside wall where the inclination angles ranged from 0.0056 rad to 0.0067 rad. The maximum inclinations occurred 3900 mm from the outside wall where the floor settled approximately 13 mm. In the area near the outside wall (0mm and 900 mm) and by the doorway (7550 mm), the local inclination angles were between 0.002 rad and 0.0038 rad. The study shows that residual deformations in this office exceed the permissible residual deformation limit and the perception of the occupant that the floor was inclined further verifies the literature review findings.

- 3) Local floor inclinations of 0.0067 rad were measured in the occupied office space. These measurements were above the permissible residual deformation level. The results confirm the literature review findings given the fact that the occupant had mentioned being inconvenienced by the feeling of the floor not being level.
