# Seismic Design and Performance of Nonstructural Elements

**Reducing the Risks of Nonstructural Earthquake Damage – A Practical Guide**

FEMA E-74 / January 2011

An EERI Technical Seminar funded by FEMA/Department of Homeland Security

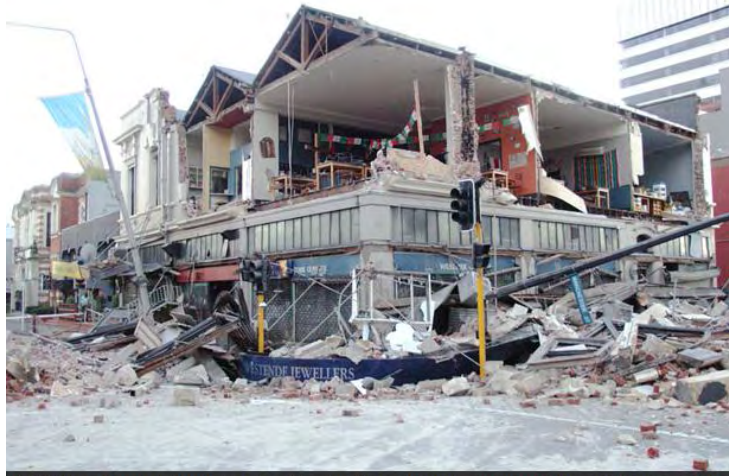
This building on the corner of Worcester St and Manchester St in central Christchurch was badly damaged by the earthquake. Photo / Danny Baré

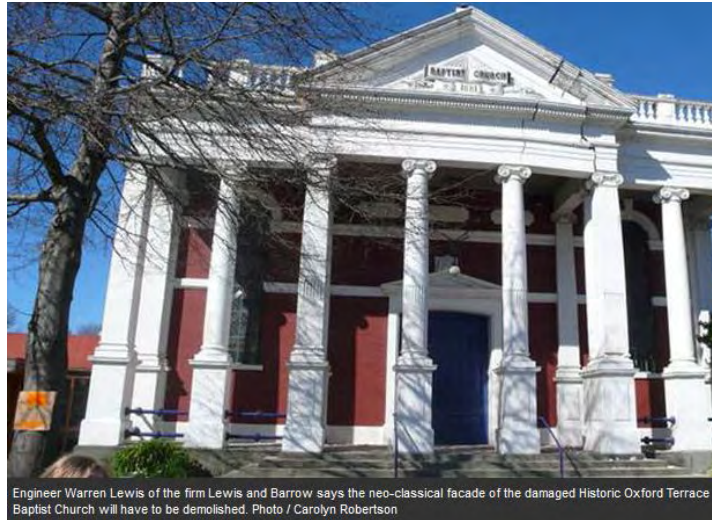
Engineer Warren Lewis of the firm Lewis and Barrow says the neo-classical facade of the damaged Historic Oxford Terrace Baptist Church will have to be demolished. Photo / Carolyn Robertson

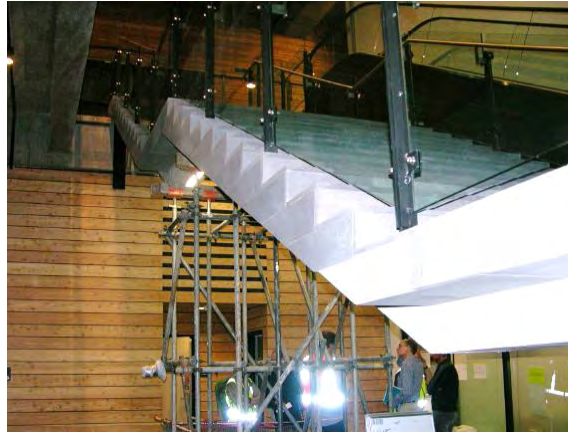
Damage in the main stairs inside the Christchurch City Council building in the Sept. 2010 earthquake

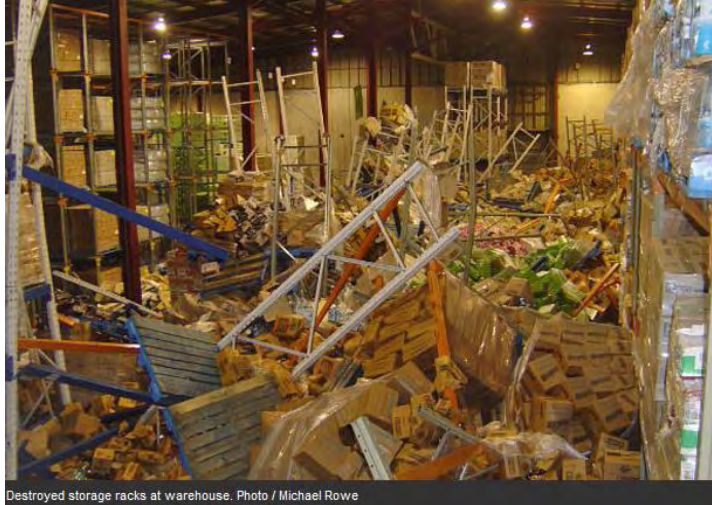
Destroyed storage racks at warehouse. Photo / Michael Rowe

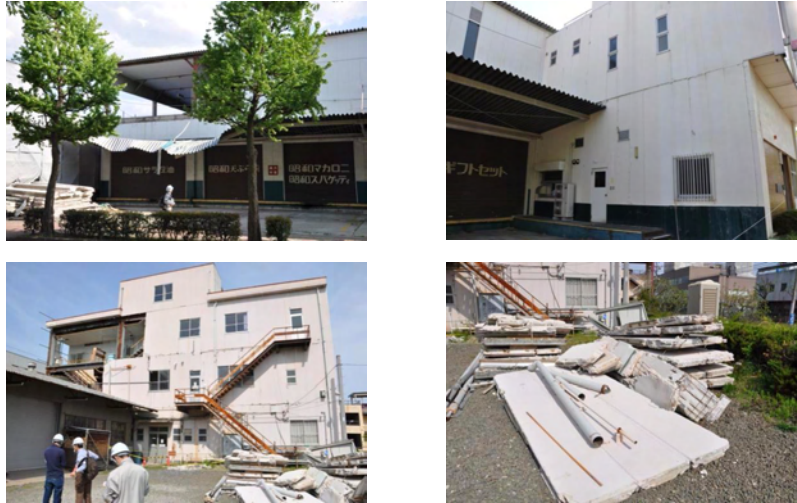
Exterior cladding damage, (Photos courtesy of Dr. Dimitrios Lignos)

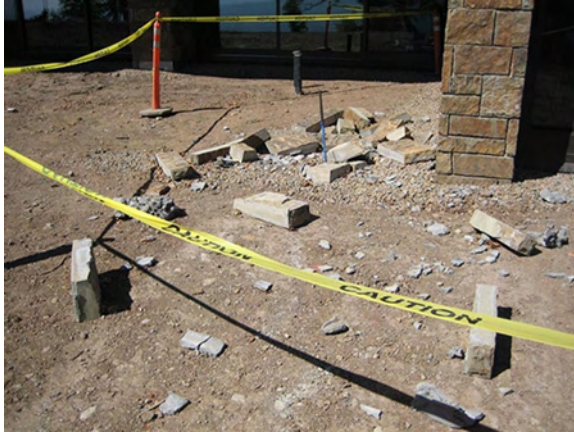
Inspection revealed missing dovetail anchors, missing pencil rods, and weak stone-to-stone mortar

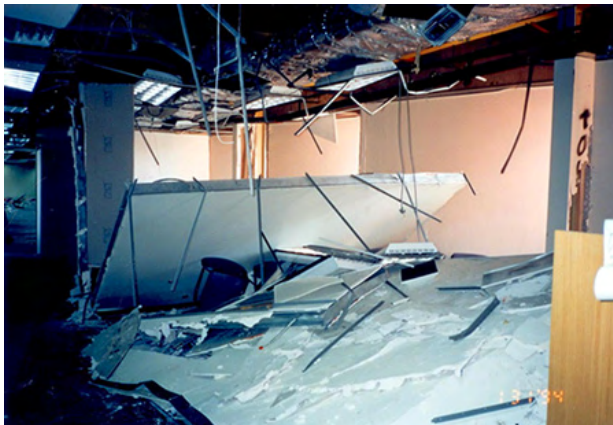
Failure of inadequately braced partial-height metal stud partitions in the 1994 Northridge Earthquake

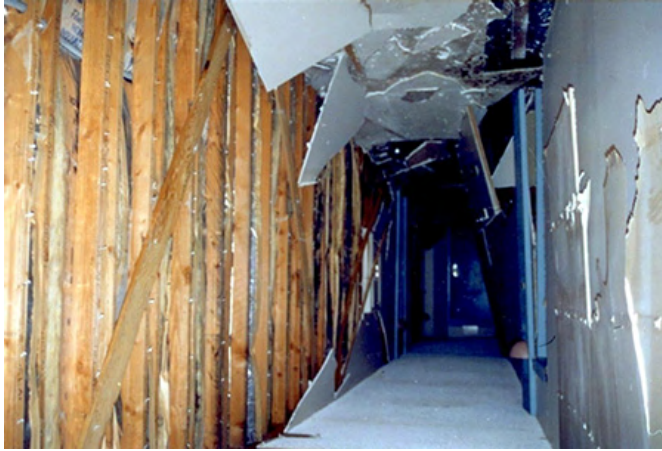
Damage to wood stud wall spanning floor-to-floor in the 1994 Northridge Earthquake

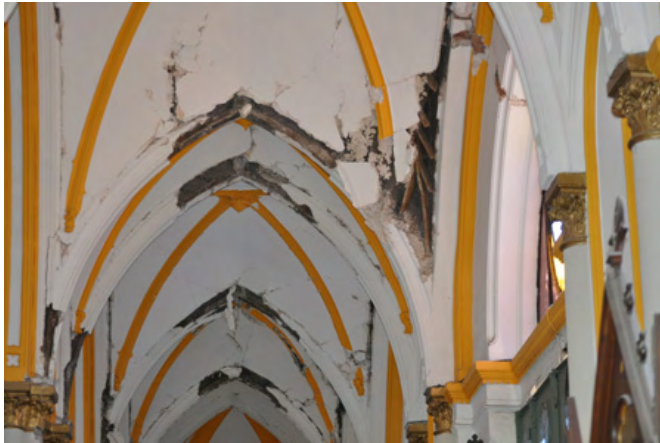
Damage to historic, ornate wire lath and plaster ceiling in the 2010 M8.8 Chile Earthquake. Wire lath is attached to arches or to wood furring suspended from the roof framing

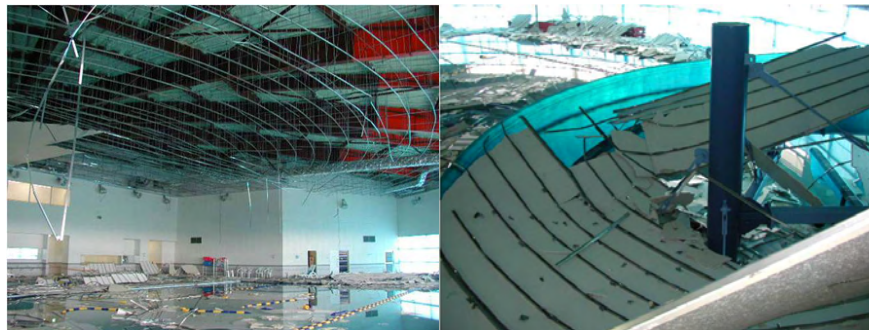
Complete collapse of a large suspended gypsum board ceiling over a swimming facility in Japan. This type of failure has been replicated on the E-defense shake table

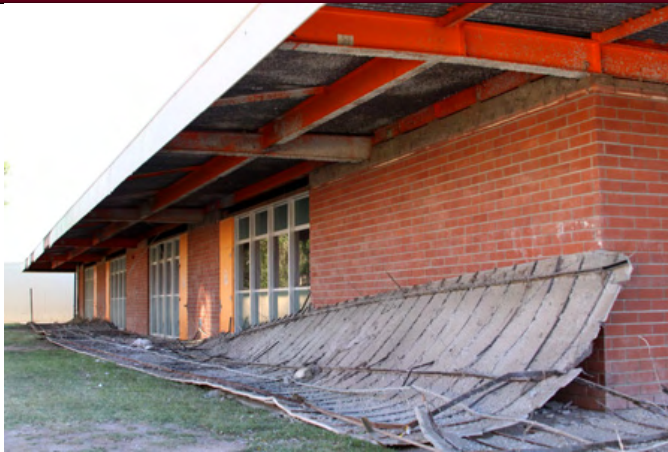
Collapse of exterior soffit at Jefferson Elementary School in Calexico in the 2010 Baja California Earthquake; approximately 1200 sq ft of soffit collapsed at this school built in the 1960's

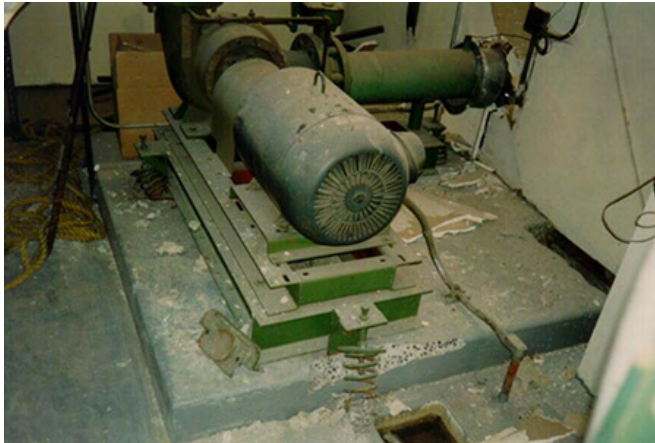
Failure of pump mounted on three vibration isolators including damage at wall penetration in the 1994 Northridge Earthquake

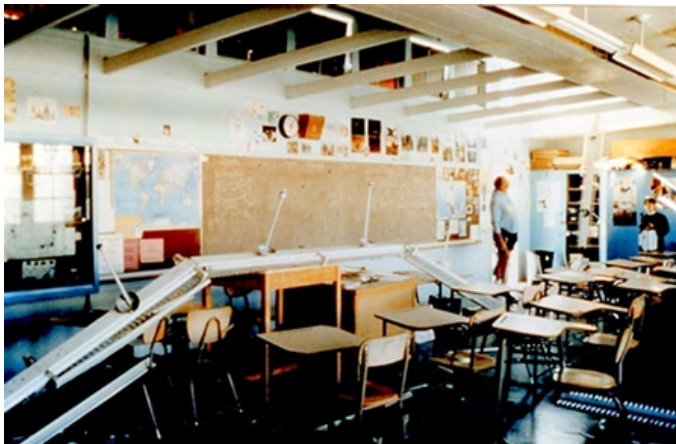
Failure of a strip of pendant light fixtures at Dawson Elementary School library in 1983 M6.4 Coalinga Earthquake; support stems failed at the ceiling connection and stems came down with the lights

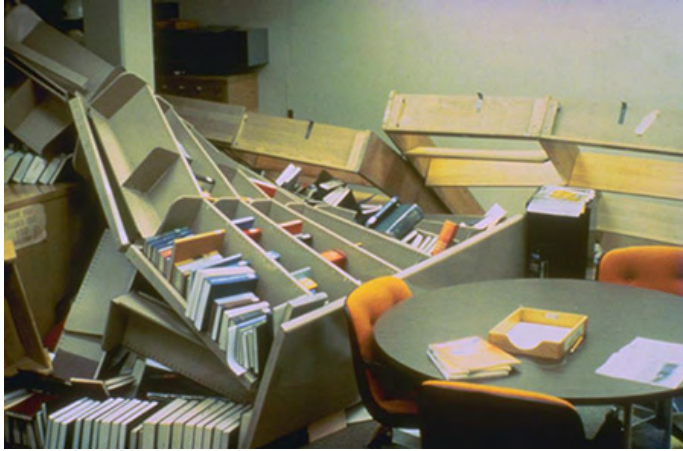
Failure of poorly anchored wood and metal book shelves at the Lawrence Livermore Laboratory, Livermore, California

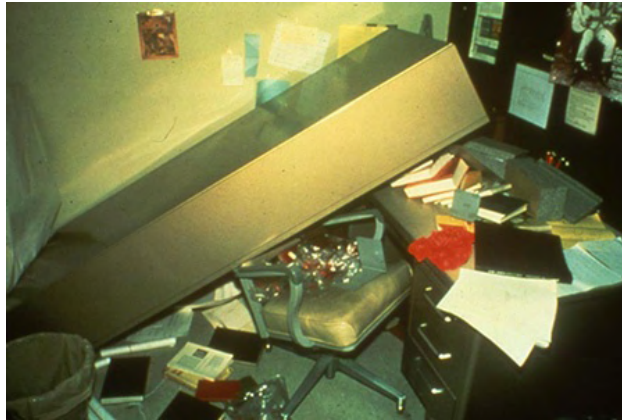
Bookcase overturned onto desk in the 1971 M6.6 San Fernando Earthquake

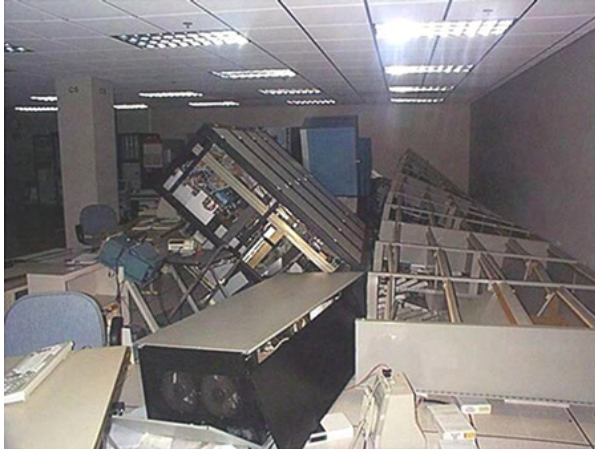
Damage to communication and computer racks

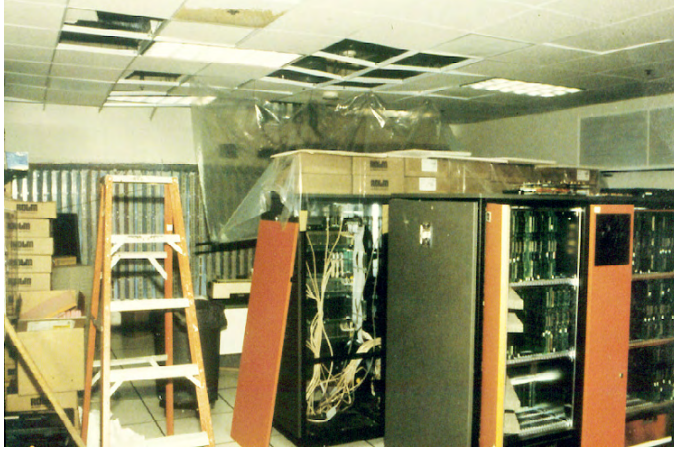
Damage to ceiling and sprinklers resulted in water damage in room full of computer racks
