# Field Manual for post-earthquake damage and safety assessment and short term countermeasures (AeDES)

EUR 22868 EN - 2007

# **Field Manual for post-earthquake damage and safety assessment and short term countermeasures (AeDES)**

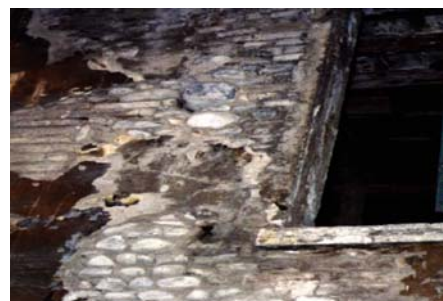
*Sassuolo (MO): pebbles and bricks*

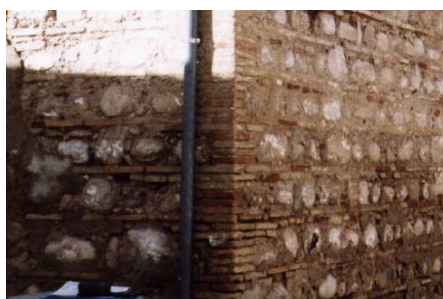
*Cast. dei Sauri(FG): Rubble stone masonry with brick courses*

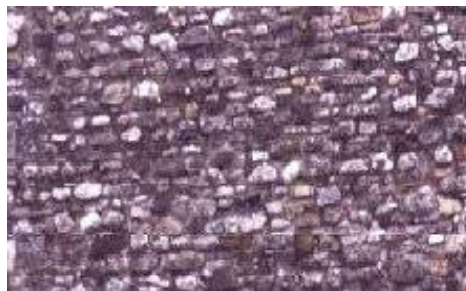
Benevento: rubble stone with fairly regular layout

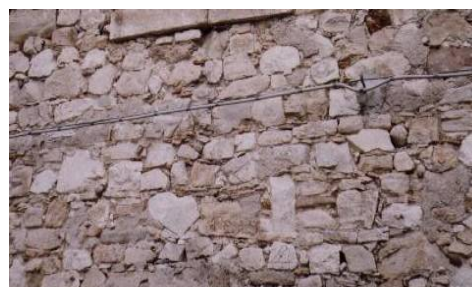
San Angelo Limosano (CB): rubble stone with irregular layout

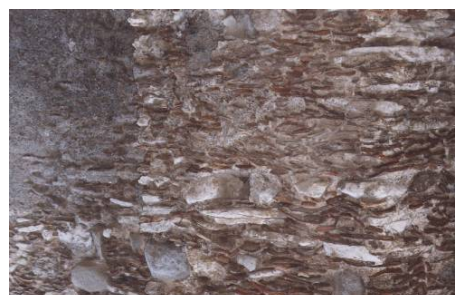
Alia (PA): irregular masonry with flat tiles and limestone

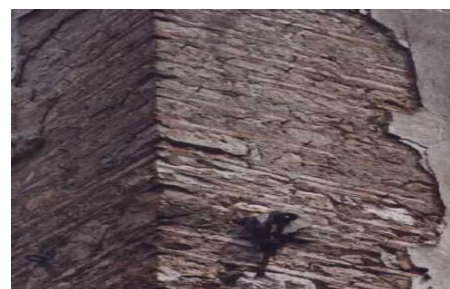
Benevento: rubble stone masonry with brick courses

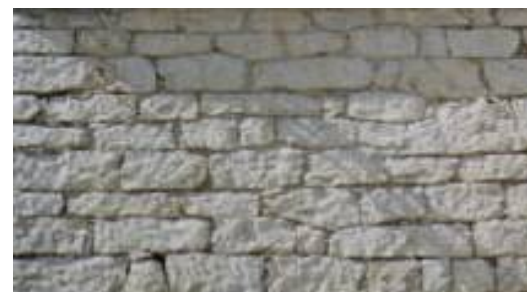
Cerchiara (CS): semi-dressed calcareous stone

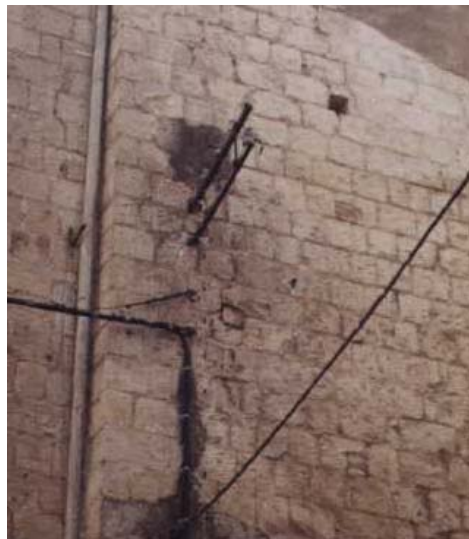
Benevento: volcanic tuff

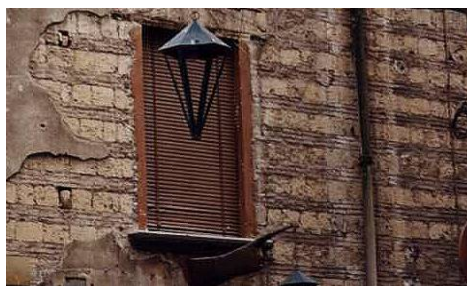
Napoli: volcanic tuff and bricks

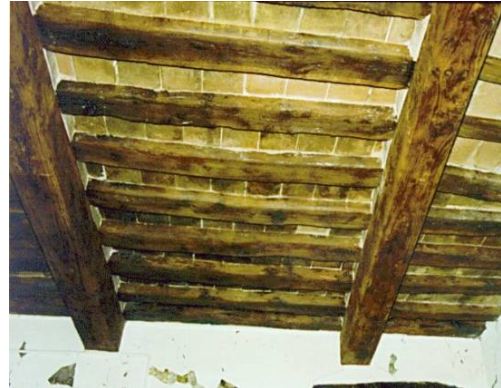
##### Wooden floor with clay tiles

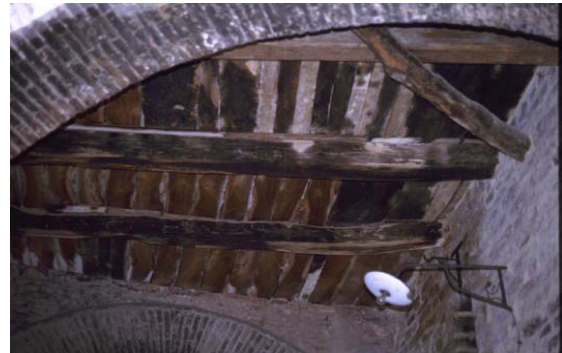
##### Wooden floor with wooden planks in a single direction

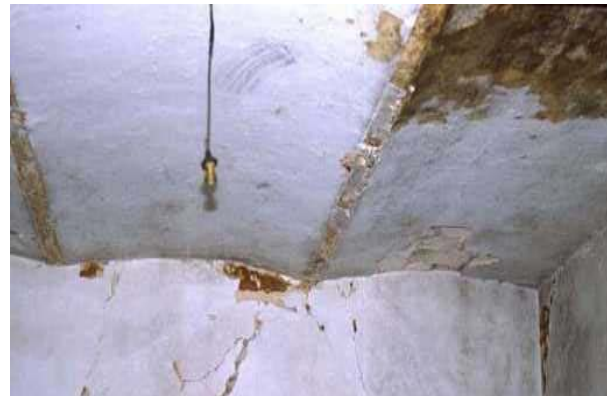
##### Floor with iron beams and shallow arch vaults

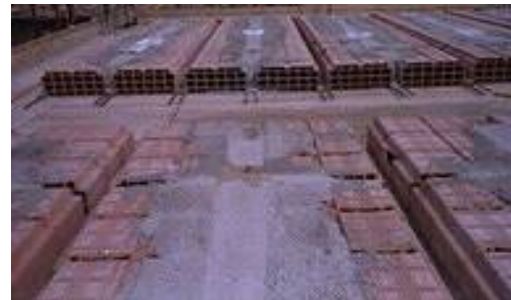
**Floor of hollow clay tiles with cast-in-place concrete joists and topping**

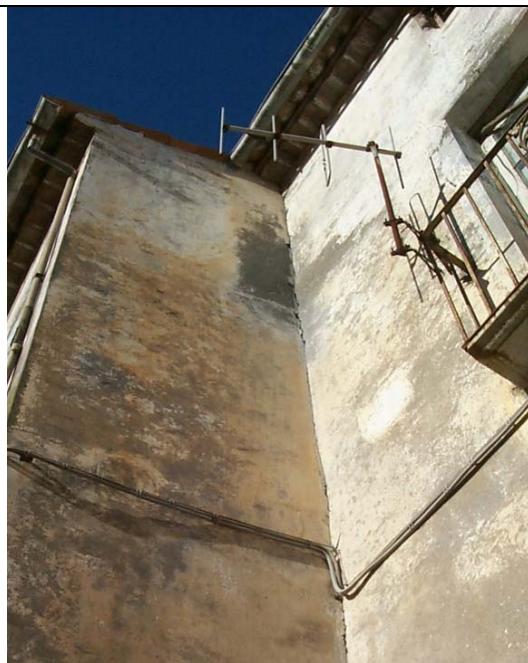
Fig. 4.5

Pre-existing out of plumb in a building located in the historical centre. Pre-existing damage grade for the building: D1

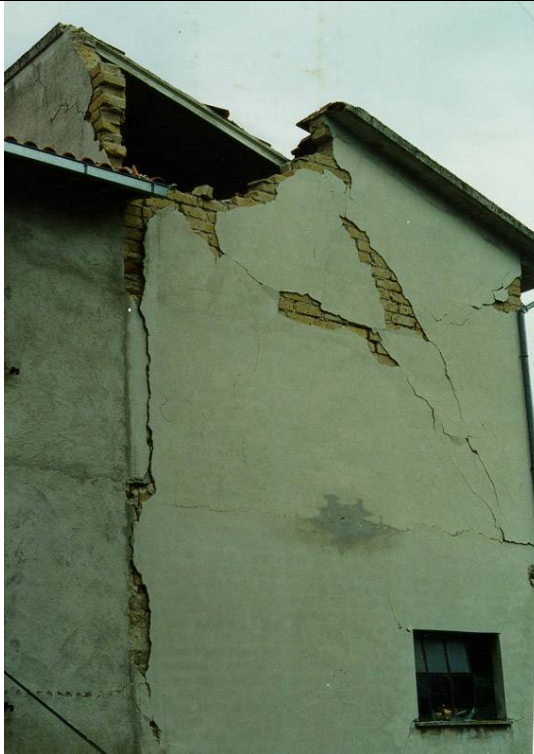
Fig. 4.7

Widespread vertical (type 1) and diagonal (type 3) cracks; almost horizontal crack (type 11) at the level of the attic. Damage grade to walls: D3 to be associated to the entire wall.

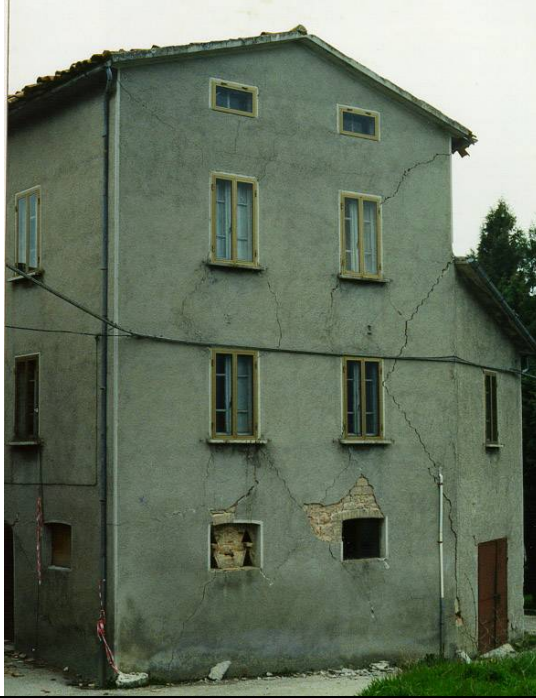
Fig. 4.8

Diagonal cracks in the second storey masonry piers (type 3), connected to horizontal cracks (type 1); on the right, a large masonry wedge, displaced by more than 10 cm, can be noticed. Damage grade: D4.

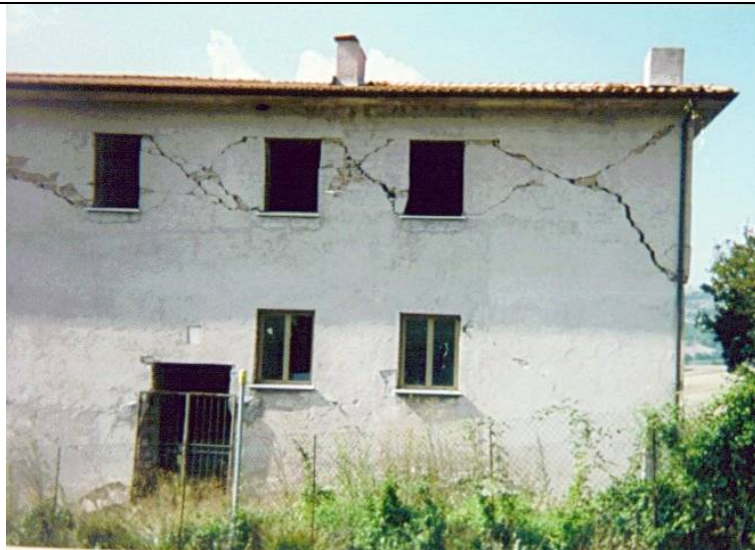
Fig. 4.9  
Diagonal crack (type 3) in a  
masonry pier, with dislocation  
at the base.  
Damage grade: D3, not far  
from D4

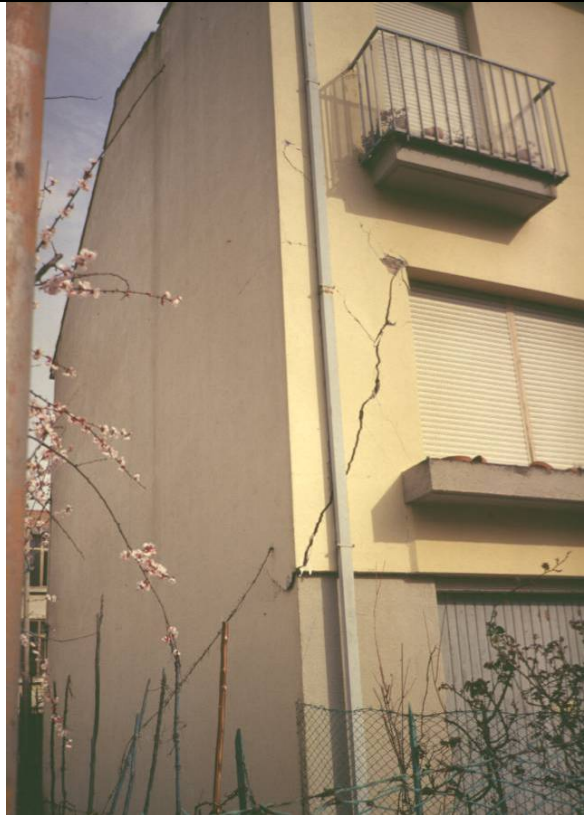
Fig. 4.10  
Vertical crack with separation  
of the orthogonal walls (type  
7).  
Damage grade: D2-D3

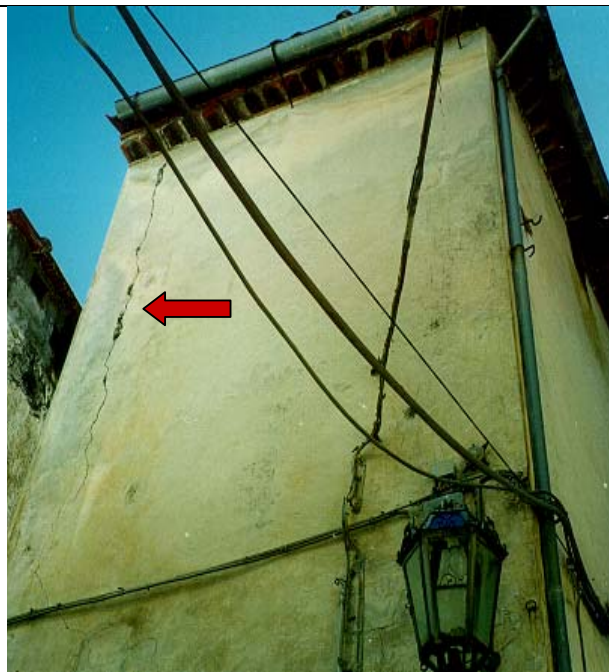
Fig. 4.11  
Interior cracks with separation  
of the orthogonal walls at the  
corner (type 7)  
Damage grade: D2-D3

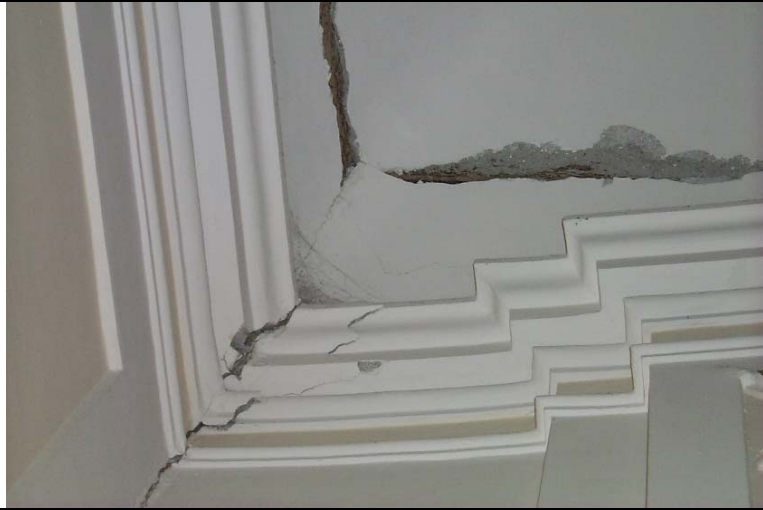
Fig. 4.12  
Vertical cracks with  
separation (type 7) of  
orthogonal walls.  
Damage grade: D3 not far  
from D4

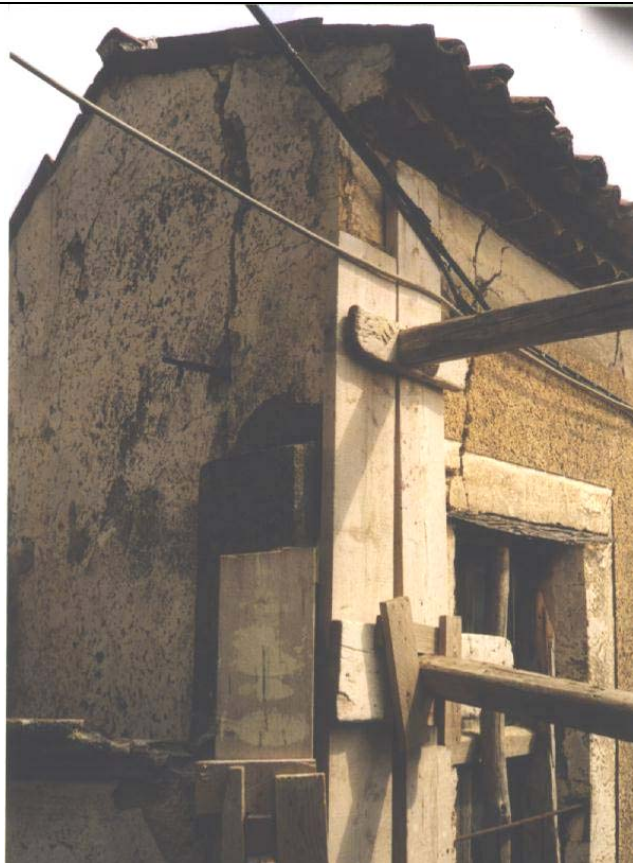
Fig. 4.13

Crack with separation of the  
attic corner (type 9)

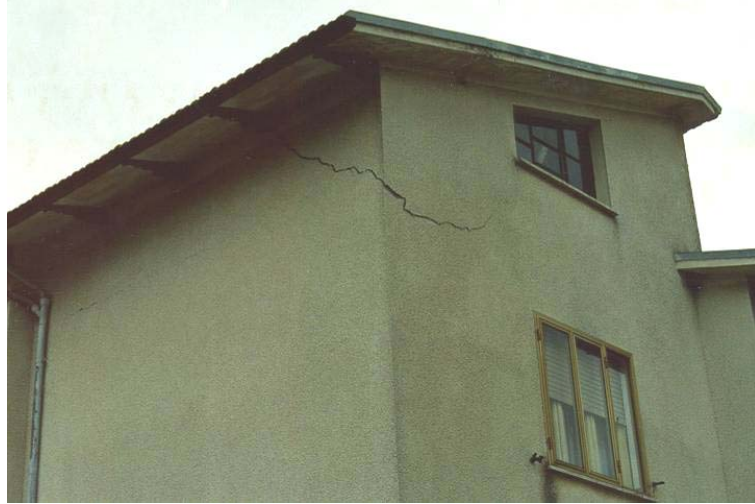
Fig. 4.14

Partial collapse of 'a sacco'  
masonry near old openings,  
due to widespread separation  
of the external wythe (type  
12); on the right, a severe  
diagonal crack (type 3),  
interesting a large portion of  
the wall and displaced by  
several cm, can be observed.  
Damage level: D4

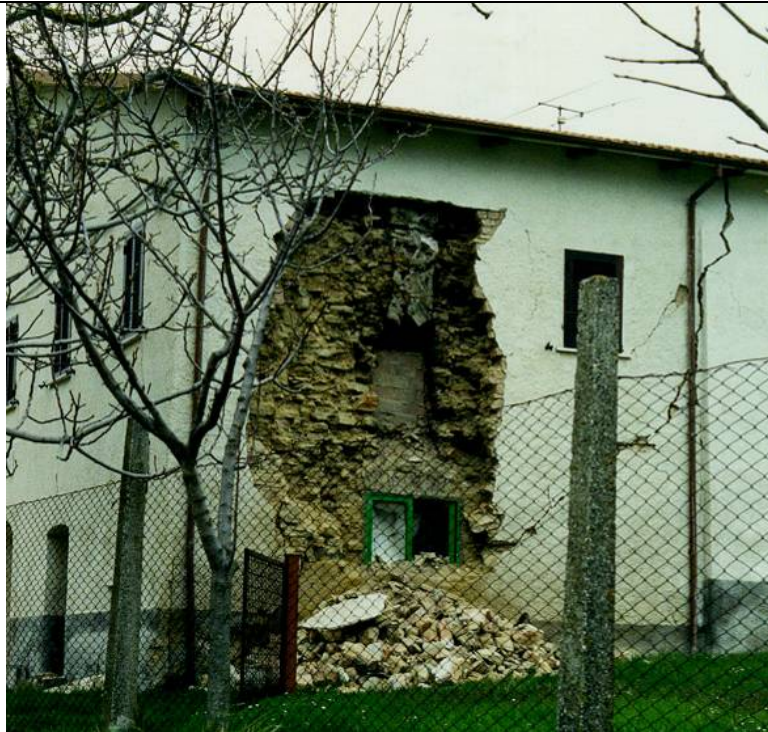
Fig. 4.15

Severe sliding at the level of the attic tie beam due to the thrust of the reinforced concrete roof (type 12; the same crack is symmetrically present on the parallel opposite external wall); crack at the corner (type 9).

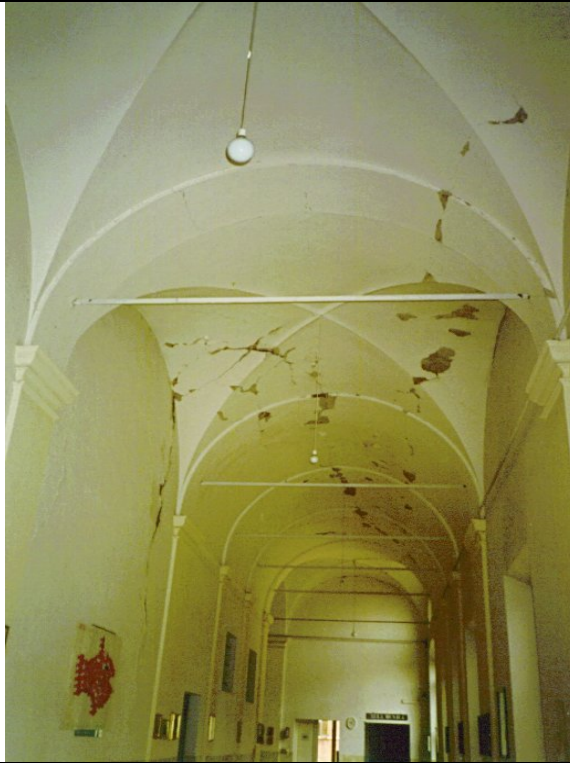
Fig. 4.18  
Longitudinal crack at the  
keystone of a cross vault and  
separation from the gable.  
Damage grade to horizontal  
structures: D2-D3

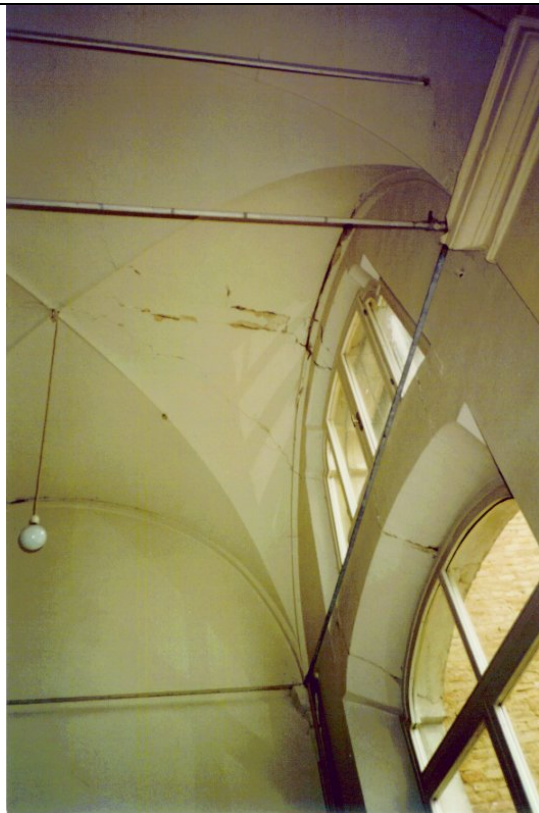
Fig. 4.19

Very severe vertical crack (type 7). Incipient out of plane failure of the façade.

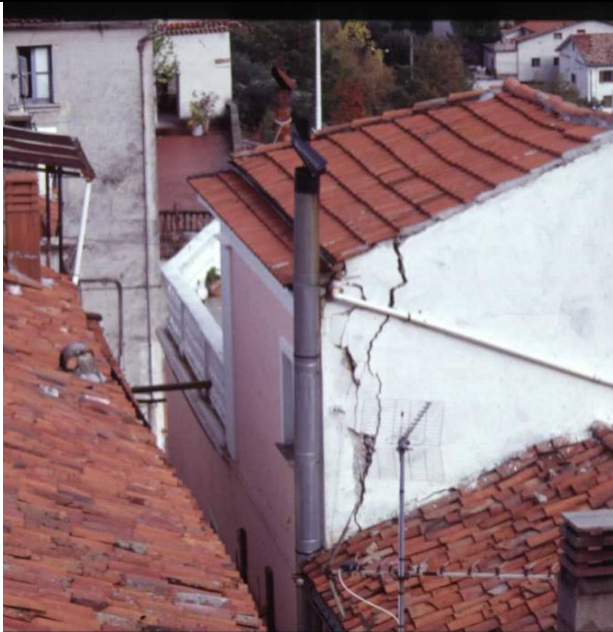
Fig. 4.20

On the left, vertical cracks due to wall separation (type 7); on the right, diagonal crack (type 3) on the masonry pier.

Masonry is made of tuff units.  
Damage grade to the wall: D3

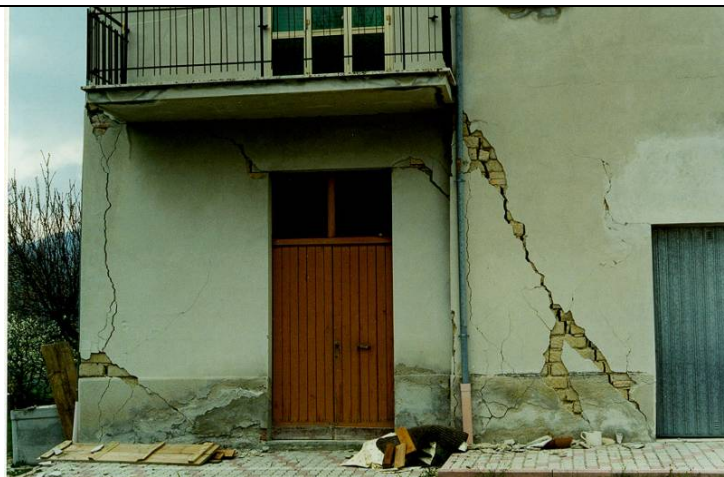
Fig. 4.21

Diagonal cracks (type 3)  
associated to an out of plane  
overturning failure mode, with  
considerable out of plumb.  
Damage grade: D4

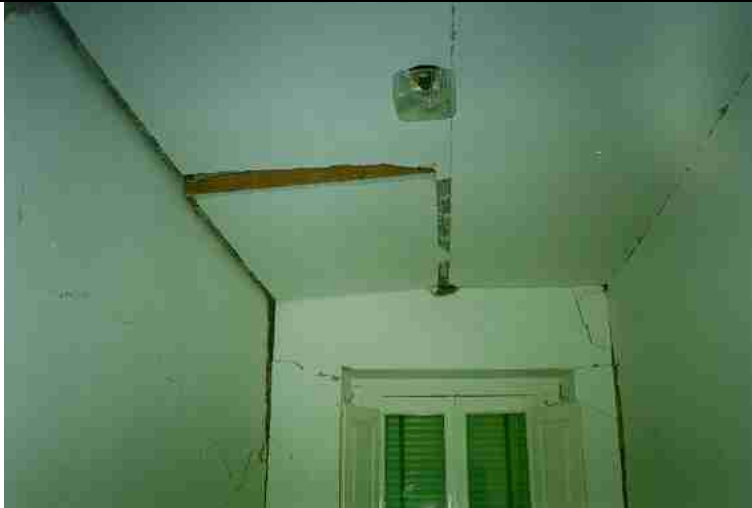
Fig. 4.23

Out of plumb (approximately 8%), related to pre-existing soil instability due to the presence of an active landslide.

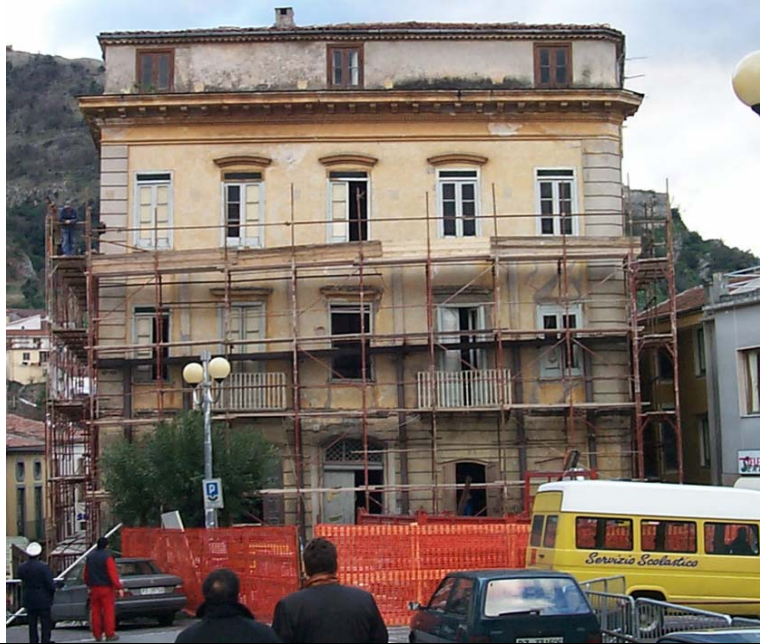
Fig. 4.24

Partial collapse of masonry walls and roof.

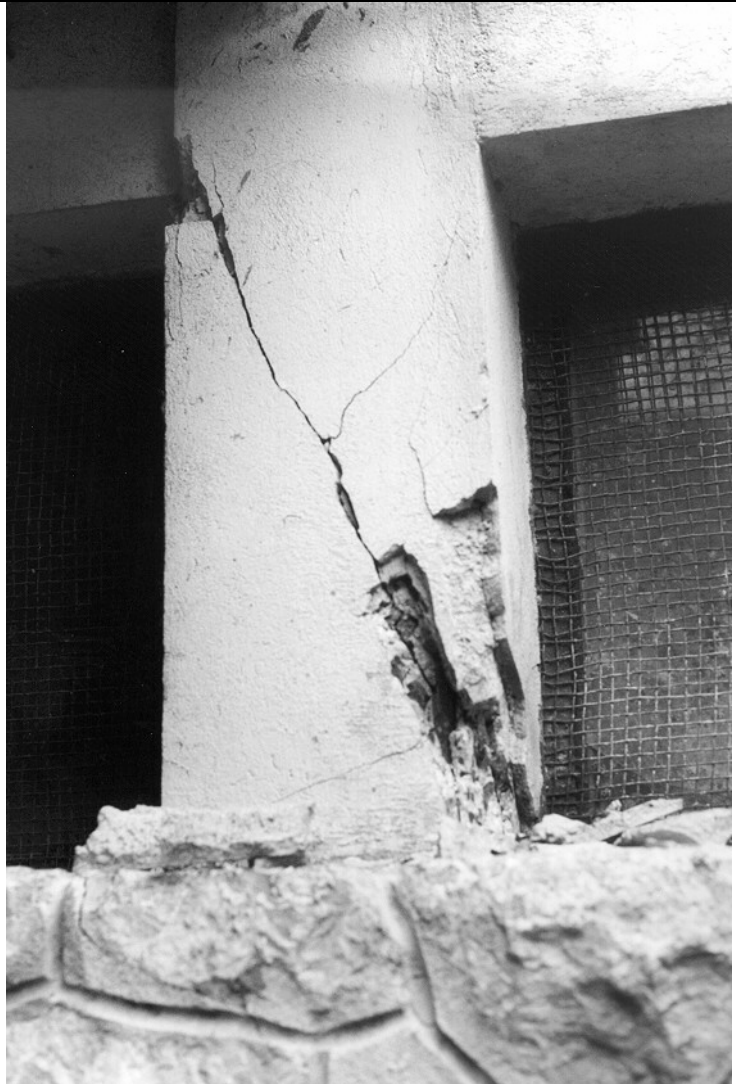
Fig. 4.27  
Cracks in several  
columns, facilitated by  
oxidation of the  
reinforcement.  
Insufficient stirrups.  
Total damage grade to  
vertical structures: D2-  
D3  
(Fabriano, 1997)

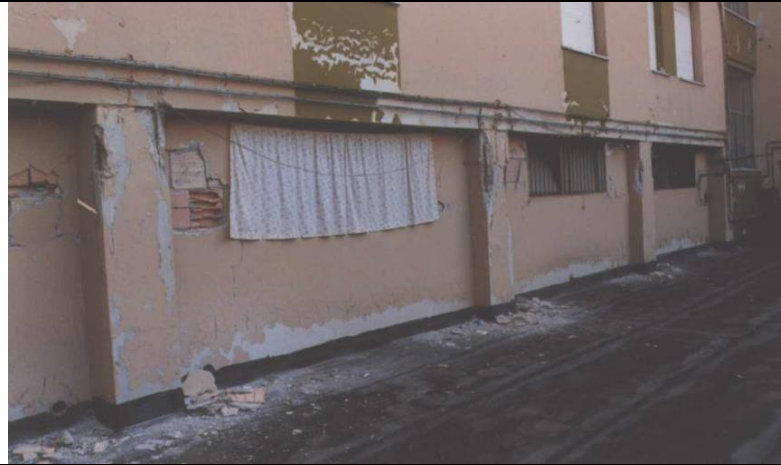
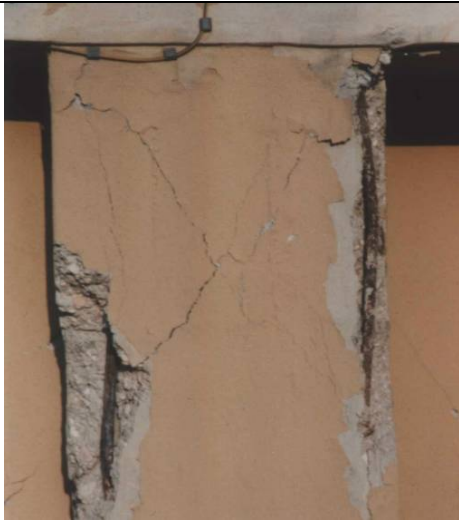
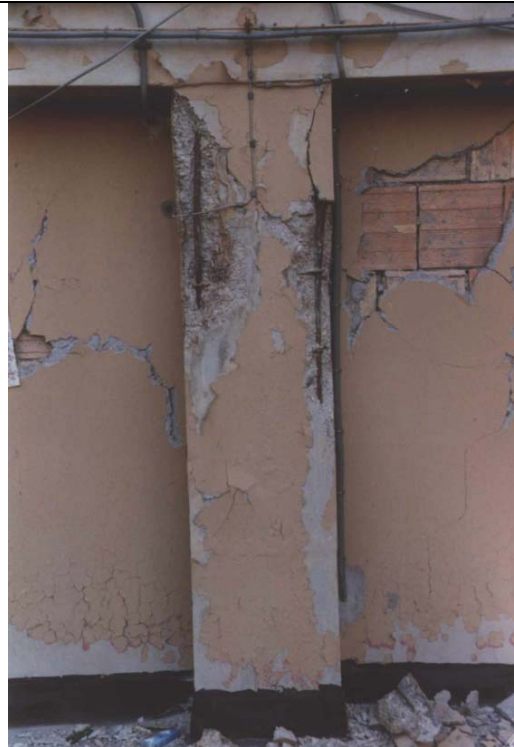
Fig. 4.28  
Concrete spalling at the  
column top section,  
slight vertical cracks.  
Damage grade: D2-D3  
(Bagnolo, RE, 1996)

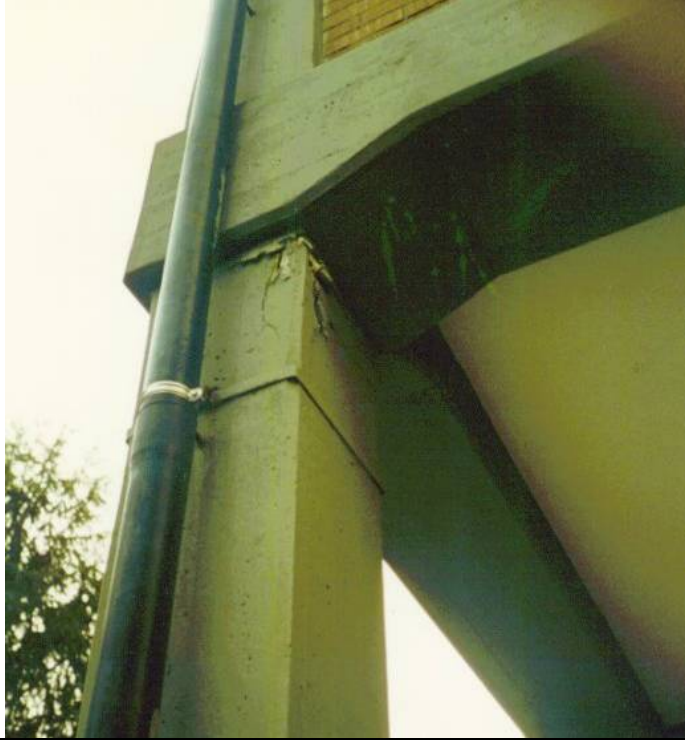
Fig. 4.29  
Damage to the beam-  
column joint with  
concrete spalling.  
Crushing of the infill  
panel.  
Damage level to vertical  
structures: D4

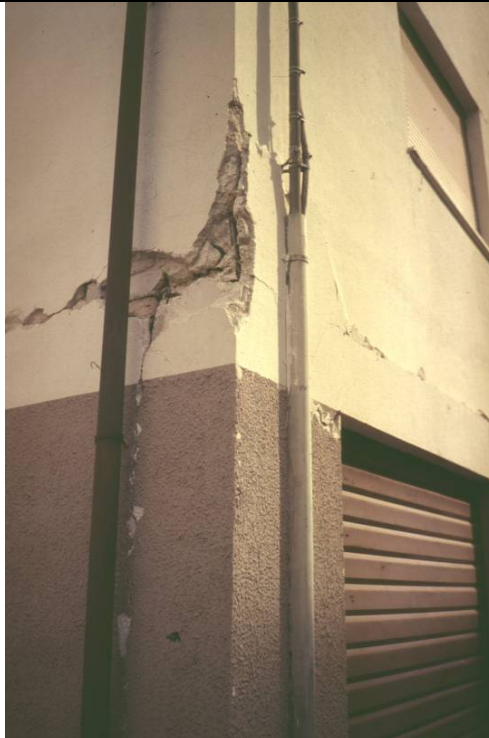
Fig. 4.32

Horizontal and vertical cracks to the infill panel, causing separation from the RC structure; partial collapse of the infill panel between the two doors.

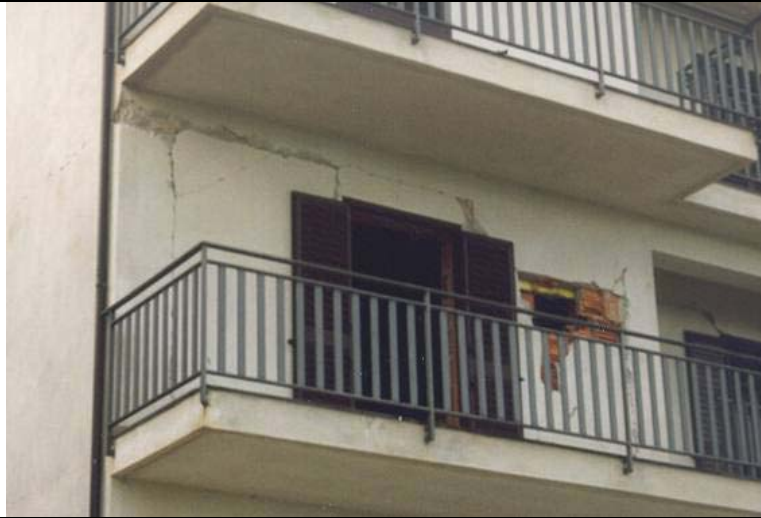
Fig. 4.33

Severe cracks in weak infills.

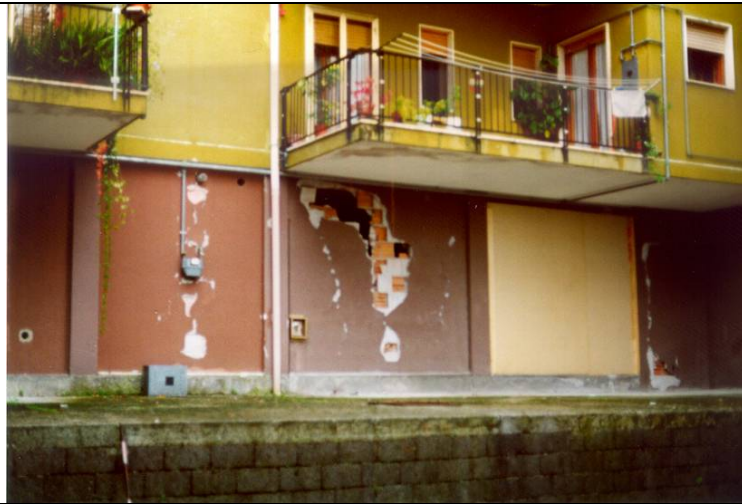
Fig. 4.34  
Out of plane overturning  
of brick hangings not  
connected to the RC  
structure.  
Damage grade to infills:  
D4  
(Fabriano, 1997)

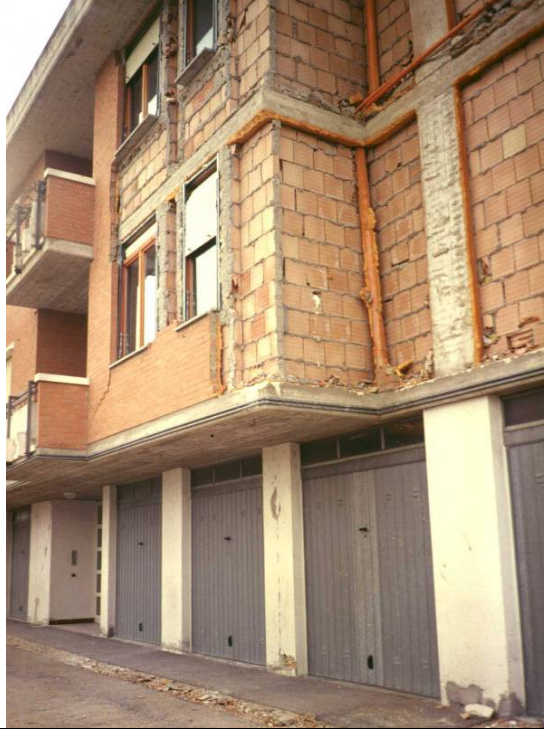
Fig. 4.35  
Very heavy damage to a  
reinforced concrete  
framed structure, with  
collapse of several  
columns at the first and  
second storey.  
Damage grade: D4-D5  
(Turkey, 1999)

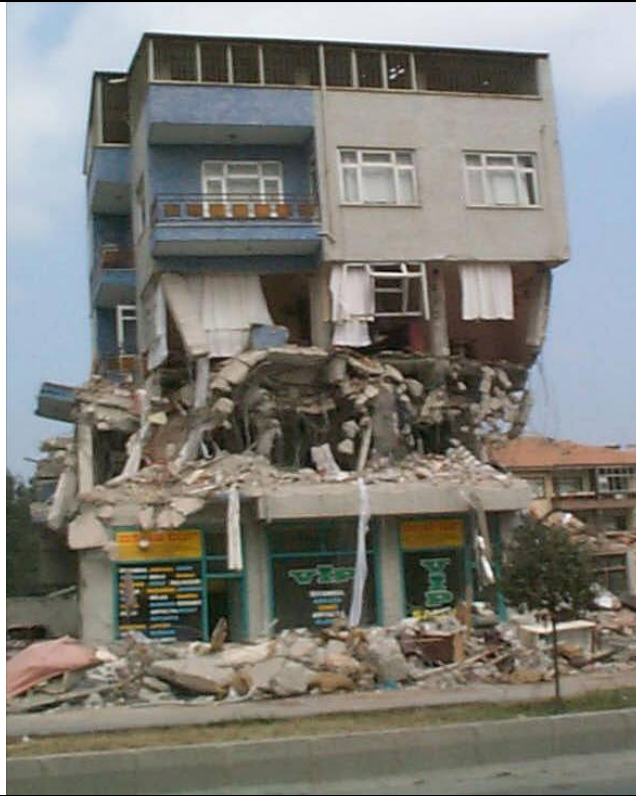
Fig. 4.36  
Total collapse  
(pancake) of a  
reinforced concrete  
building, similar to  
the one under  
construction in the  
background.  
Damage grade: D5  
(Turkey, 1999)

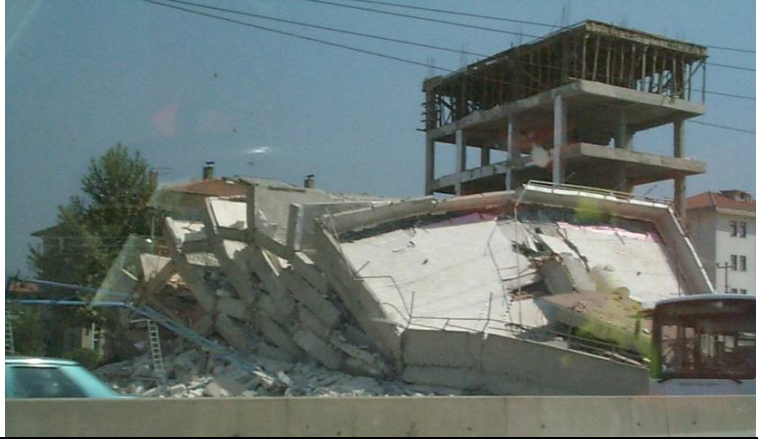
Fig. 4.37  
Collapse due to soft  
storey at the ground  
floor.  
Damage grade: D5  
(Turkey, 1999)
