**Build Change, AARGI, and EERI
Earthquake Reconnaissance Report:
M6.5 Pidie Jaya Earthquake,
Aceh, Indonesia on December 7, 2016**

May 2017

A product of the EERI Learning From Earthquakes Program

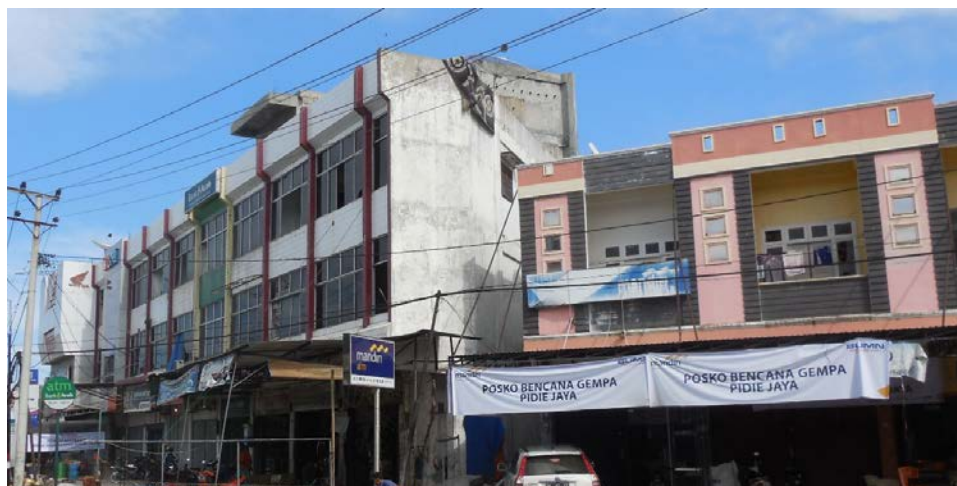
The practice of confined masonry construction is also common on low-rise shop-houses (typically 2-3 stories). This type of building is typically used for commercial purpose on the first story and residential purpose on the upper stories. Similar to the typical damage observed in other past earthquakes, the failure was attributed to soft-story mechanism of the first floor where wide opening exists as the main entrance for the commercial activity. Figure 7 shows the typical shop-houses in the affected area. BNPB reported that 78 shop-houses (BNPB, 2016) were damaged due to the earthquake. This number is relatively small compared to the number of damaged residential houses of 19,000 (BNPB, 2016). In the survey, the AARGI team observed that additional floor constructed above the existing building might have caused the damage because there were similar unmodified shop-houses located near the damaged ones that were unaffected by the earthquake. This additional floor changed the dynamic characteristics of the structures, and there was a great possibility that the existing structural components were not designed to carry that additional load (Figure 8).

Figure 7. Typical shop-house in the affected area (photo: Muhammad Riyansyah).

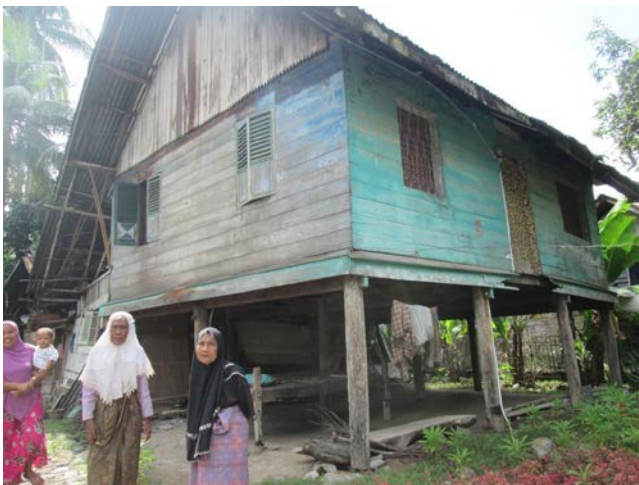
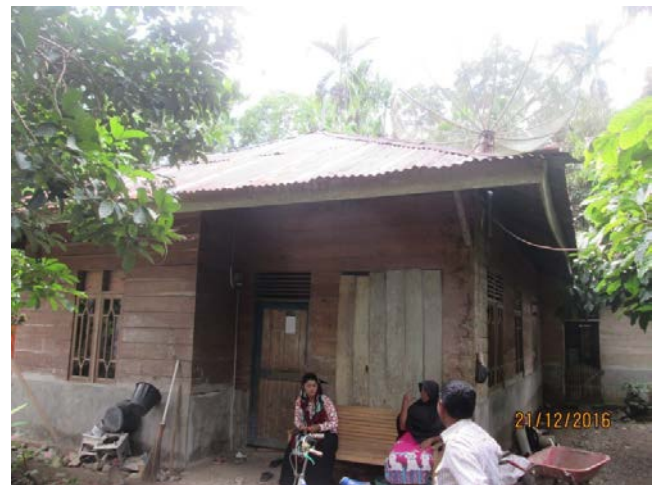
Several different types of wood frame buildings were observed. Wood-framed houses were either raised up on posts above grade (from 30 cm to 2.5 m), or were built directly on grade (Figure 16). In houses built directly on grade, a portion of the wall below the windowsill level was typically constructed using masonry or a cement-sand mortar (called skirt wall). Timber wall and roof framing were then subsequently placed above this skirt wall. One timber school building was observed following this style of construction.

Figure 16. Timber frame houses: (a) raised, (b) on-grade with skirt wall (photos: Build Change).

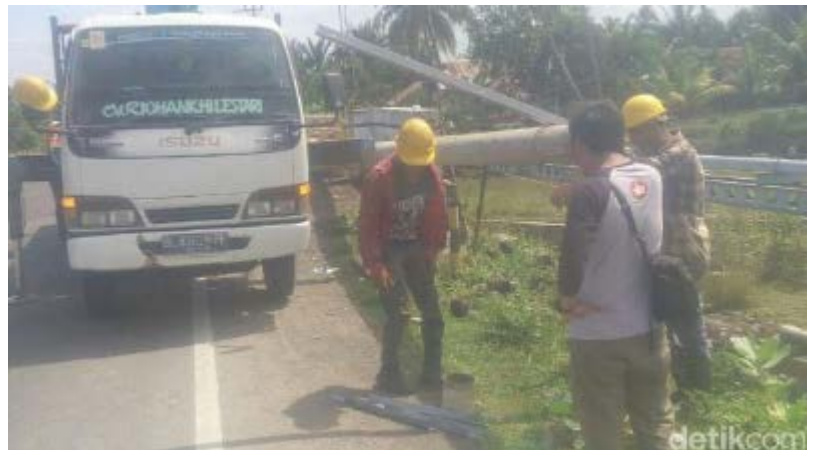
The earthquake interrupted the electrical distribution to over 40,000 customers. It was recorded that 84 transformers, electrical cable lines, and more than 100 low-voltage and medium-voltage electrical poles (Figure 20) were damaged during the earthquake. The damage was concentrated at electrical facilities located in Samalanga, Meureudu, and Beureunun regions. The power distributed in the Samalanga region is 500 kW, and the power distributed in Meureudu and Beureunun is around 6 MW (Jati 2016).² Some retrofit and reconstruction measures, such as reconnecting the broken electrical cable and reconstruction of low-voltage pole, were conducted by the state electricity company (Perusahaan Listrik Negara, or PLN) to recover the interruption. The electrical distribution was 50% recovered within two days after the earthquake, and it was completely recovered within four days after the earthquake (PLN 2017).³

Figure 20. (a) Damage on electrical poles during the Aceh earthquake, (b) recovery efforts conducted by the State Electricity Company (photos: Augustinus 2016).⁴

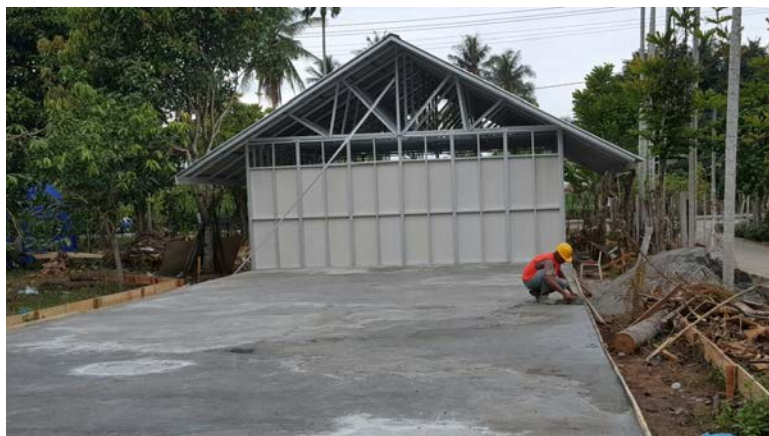
Collapsed school buildings were almost completely cleared or demolished by the time of the visit. The school reconstruction and renovation will be overseen by the Ministry of Public Works (PU). PU built temporary building structures (Figure 26) for the 24 schools that were badly damaged, targeted to be completed by end of February. The budget and planning for reconstruction of permanent schools were still under confirmation and waiting for approval. Once started, the expected time frame for reconstruction is 6-12 months.

Figure 26. Construction of temporary school (photo: Puskim Kemenpupera).¹²

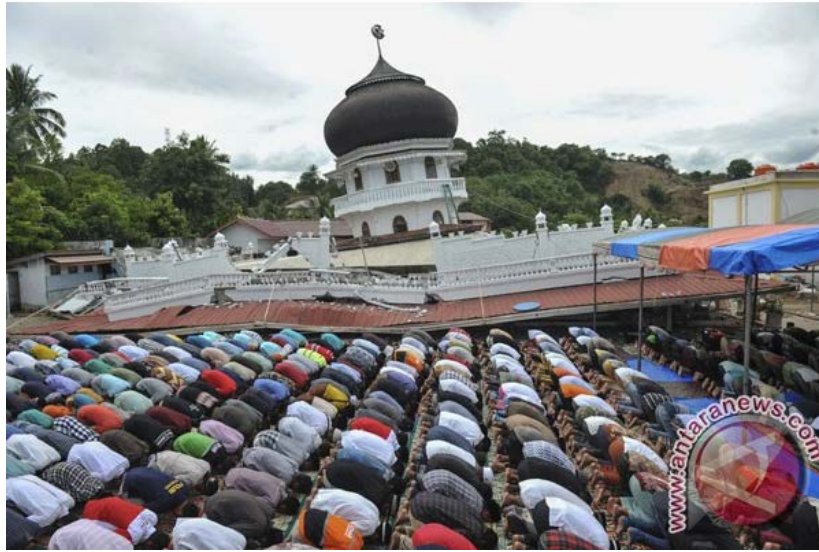
Reconstruction of the mosques was one of the main priorities for the government. Figure 28 shows the community gathered beside the collapsed central mosque to conduct their routine Friday prayer.

Figure 28. Friday prayer near the central mosque at Pidie Jaya following the earthquake (photo: Antara News, 2016).¹⁷

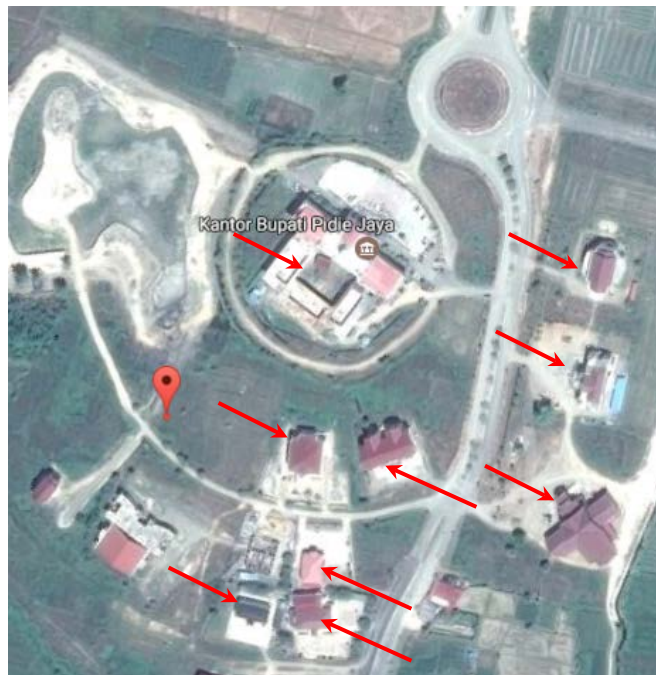
The AARGI team visited eight government offices that are located adjacent to one another (Figure 29). The building typology of the government offices is reinforced concrete frame with masonry infill. Most of the buildings performed well during the earthquake, with notable non-structural damage to the infill wall, ceiling, and roofing material. Some sections in the buildings were advised to be closed for access until further investigations were conducted to clean the falling hazard from the damaged nonstructural components. One building experienced structural damage to the columns and beams at the basement floor. This building was labeled unsafe, and further investigations, as well as retrofit design and construction, were later conducted.

Figure 29. Location of surveyed government offices.
