## PERMISSIBLE RESIDUAL DEFORMATION LEVELS FOR BUILDING STRUCTURES CONSIDERING BOTH SAFETY AND HUMAN ELEMENTS

Jason McCormick<sup>1</sup>, Hiroshi Aburano<sup>2</sup>, Masahiro Ikenaga<sup>3</sup>, and Masayoshi Nakashima<sup>4</sup>

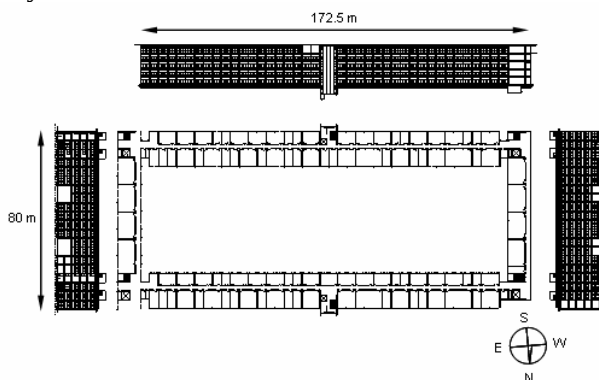
Figure 2 Plan and elevations for the target structure

In order to further verify the 0.005 rad residual deformation index, an investigation of the residual deformations found in an occupied building located on the Uji campus of Kyoto University was completed. The building was constructed in 1970 and is a 5-story steel moment frame. The structure consists of 43 spans in the long direction and 20 spans in the short direction. The span lengths are 3750 mm and the floor heights are 3300 mm. Figure 2 provides the plan and elevation views of the building. On the east side of the structure, there are two, 2-span by 2-span openings for emergency vehicle access, while the openings on all other sides are only one bay by one bay for conventional vehicle access.

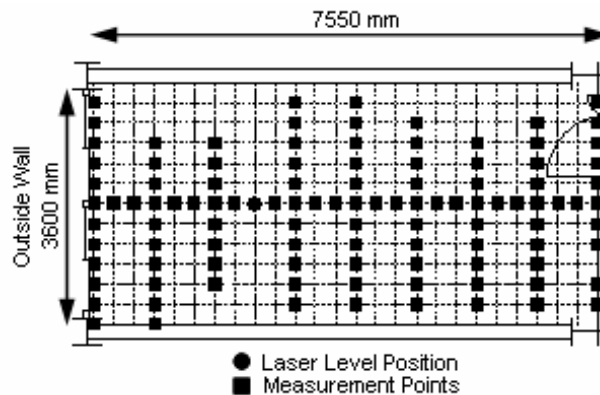
Figure 4 Plan view of the occupied office space and the measurement points

The second study focused on residual deformations within an occupied office space located on the second floor of the south corridor. The room had plan dimensions of 3600 mm by 7550 mm. As with the previous study, the laser level was used to provide a datum for the floor inclination measurements. The laser level was placed 2400 mm from the outside wall and 1800 mm from the two side walls. A total of 107 measurements were taken as can be seen in Figure 4. The choice of measurement points was dictated by permanent furniture present in the office space. This particular office space was chosen because the occupant felt that the floor was inclined, but did not experience dizziness or headaches as a result of it.
